ASSESSMENT OF THE MOST DAMAGED HISTORIC CENTRES OF THE REGION EMILIA ROMAGNA DUE TO THE EARTHQUAKE OF THE 20th AND 29th OF MAY 2012

V.I. Novelli, Department of Architecture and Civil Engineering, University of Bath, Bath, BA2 7AY, UK, V.I.Novelli@bath.ac.uk

Key words: Emilia Romagna, historic centres, damage scenarios; assessment; seismic vulnerability

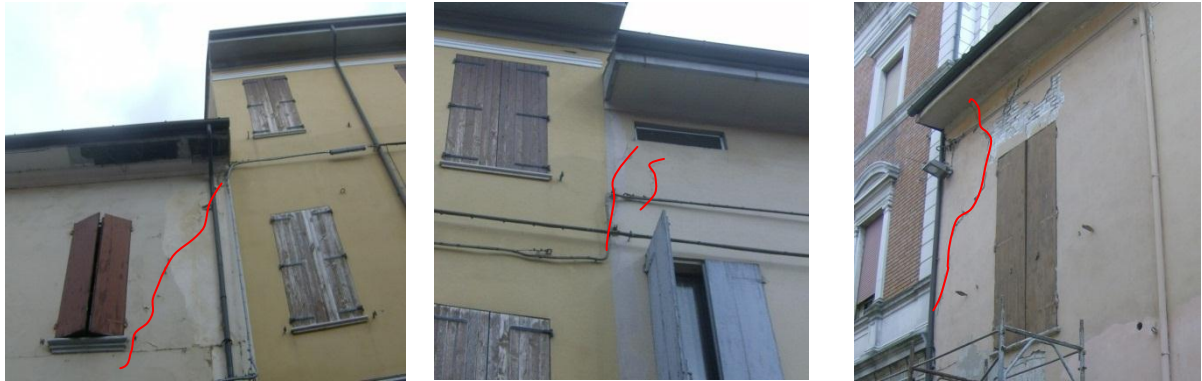
In a small number of cases, reinforced concrete frame buildings are also present in adjacency to masonry houses. This layout has direct implications on the seismic behaviour of single buildings within clusters, and leaves some of them at severe risk of pounding, as observed on site, see Figure 5.

Figure 5: *Pounding effect due to different heights of buildings in the historic center of Cento.*

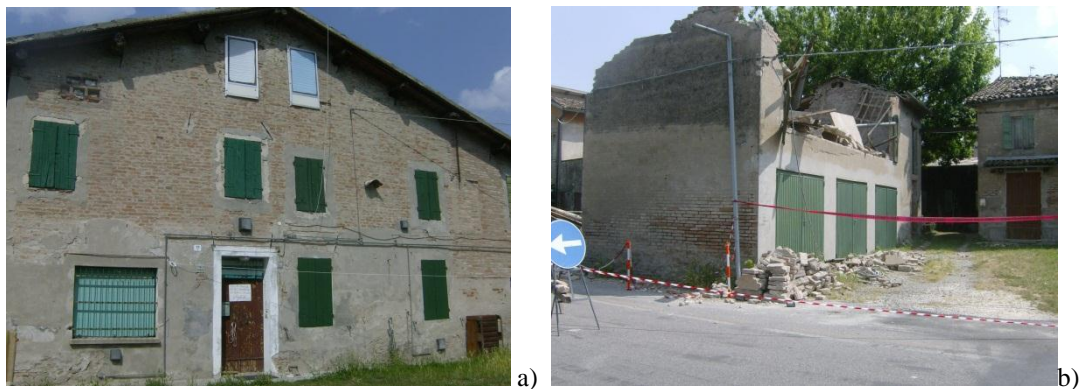
Moreover, it has been observed that some of these houses are vacant and others are completely abandoned to their decay, the lack of maintenance and low quality of their original masonry fabric, contributing significantly to their poor structural response to the seismic events; see Figure 6 and Figure 7.

Figure 6: *a) Modification of the original opening layout in the isolated house in the neighborhood of Casumaro (Fe) b) Alteration of the original plan of the isolated house between S. Felice sul Panaro and Rivara.*

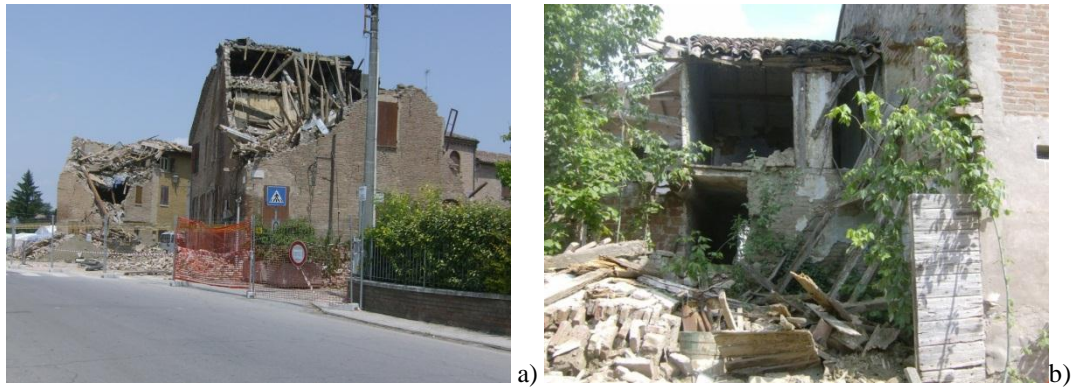
Figure 7: a) Isolated houses between S. Felice sul Panaro and Rivara and b) Isolated house in the neighbourhood of Casumaro characterised by low quality of materials and mortar.

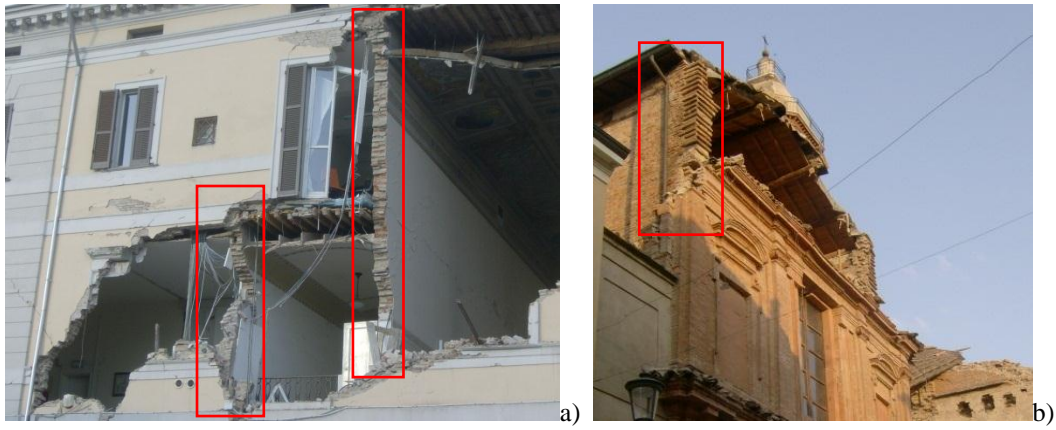
In general, in the historic centres it has been surveyed a good quality of the masonry fabric and high level of maintenance of the buildings. However the slenderness of the façades which characterised most of the historic buildings, inspected on site, has been considered the major cause of several in plane and out plane mechanisms, see Figure 9.

Figure 9: a) In plane failure of the City Hall in Sant'Agostino b) Out of plane of the building in Curtatone street close to the Cathedral in Mirandola

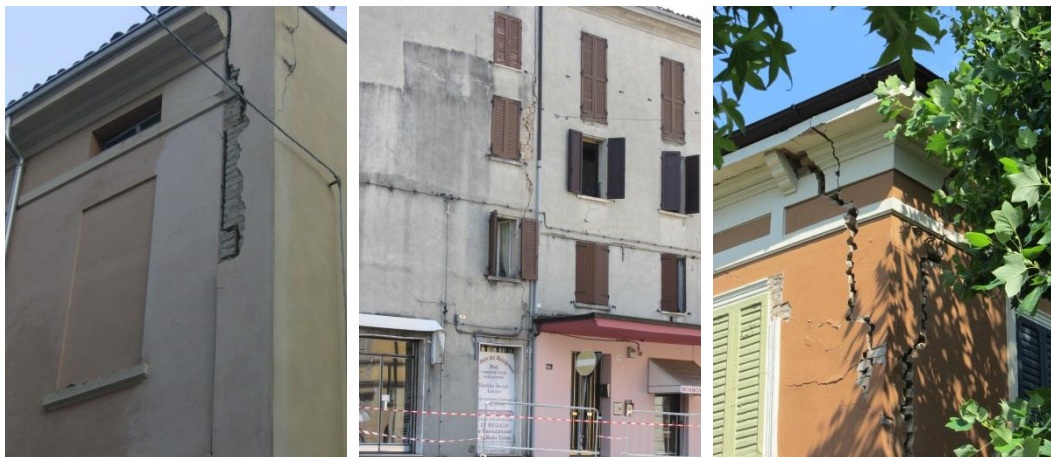
The types of damage observed in the several areas of Emilia Romagna region has pointed out that the partial or total overturning of the façade; see Figure 15; is usually caused by the following issues:

- poor quality of the connections between the entire walls or part of them
- poor quality of the masonry fabric and mortar
- lack of connection between horizontal structures and bearing walls lack of maintenance of masonry

Figure 15: *Examples of out of plane in the historic center of Mirandola.*

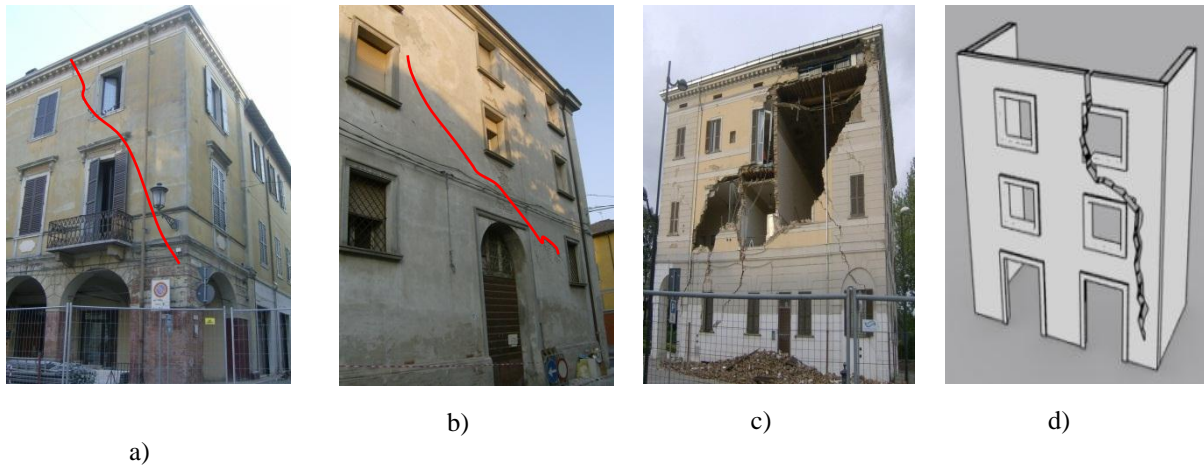
This involves that some piers being more vulnerable than others might be failing in a combination of bending and shear, rather than just shear; see Figure 16.

Figure 16: *Examples of in plane mechanism in a) and b) historic center of Mirandola and in c) city hall of Sant'Agostino. d) Sketch related to the identified mechanism (D'Ayala and Speranza, 2003).*

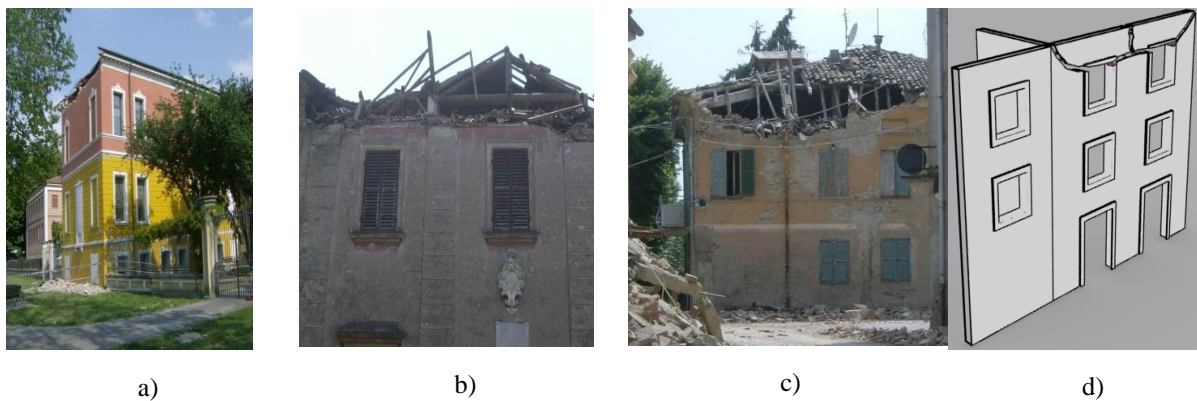
As for those restrained buildings, the constraining action is active when ties are regularly spaced over the façade, and correctly anchored and connected through to the orthogonal walls or to the floor structures. In case the ties are not properly anchored and the unstrained length of the façade is considerable respect to its thickness, it has been observed that a central trapezoidal portion of this façade, under the effect of the seismic action, tends to shift outwards, see Figure 17.

Figure 17: *Examples of Out of plane of the top level in a) and b) Mirandola, c) Rivara and in d) sketch related to the identified mechanism (D'Ayala and Speranza, 2003).*

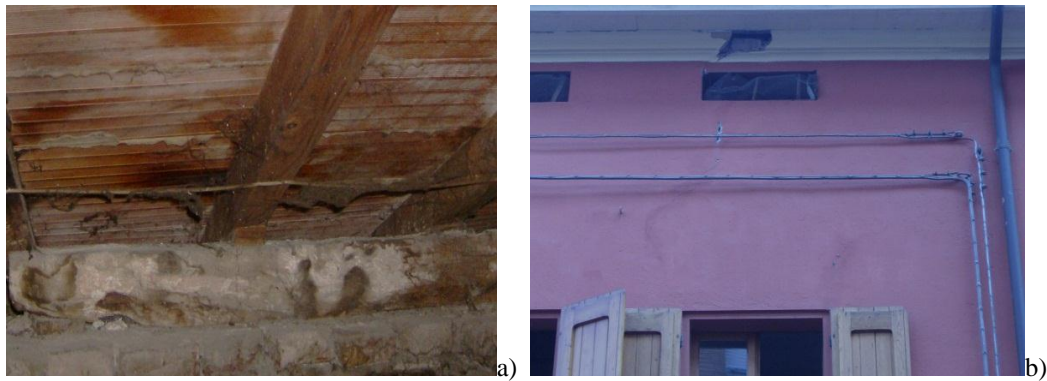
In some buildings, for which more detailed inspection has been carried out, it has been observed that timber plates are often used in order to prevent the façade from moving out from the top floor. However, it has been noted that the presence of this element might cause out of plane of the top level in cases the timber plate is not well connected and continuous along the top of the wall (see Figure 18)

Figure 18: a) Typical timber plate found at roof level in the historic center of Cento and b) out of plane of the related façade due to the discontinuity of the timber plate.

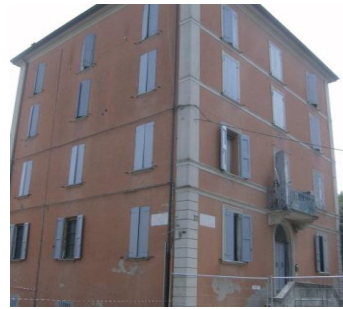
Quoins have also been identified in several historic buildings, see Figure 19. These restraining elements are effective to guarantee box behaviour of the building. However the efficiency of these elements is limited when coupled with poor masonry fabric or internally unconnected masonry. It should also be noted that in some cases the quoins might be only

Figure 19: Typical quoins on both edges of the façades. The building on the corner between Guglielmo Marconi street and Costa street in Crevalcore suffers of shears on the spandrels.

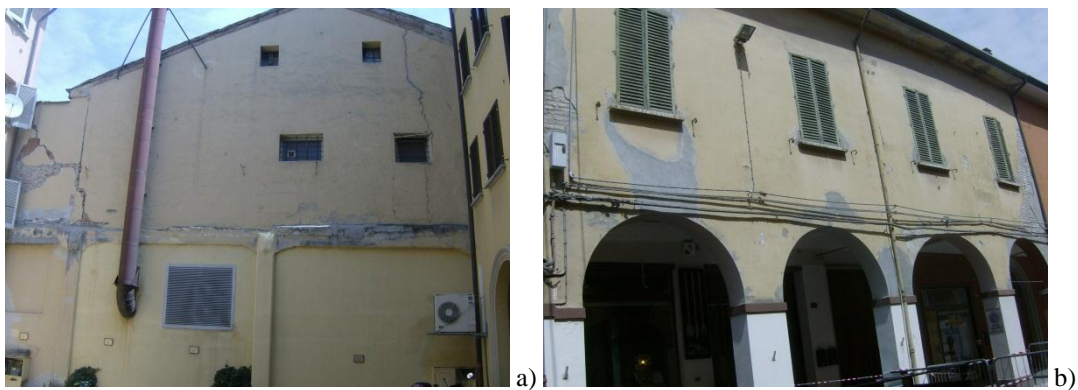
In some cases, in particular for those buildings with commercial activities at the ground floor the damage is concentrated from the second level, since the ground floors are often refurbished with a new structure, usually made in RC frames, see Figure 20.

Figure 20: a) South west and b) north west façades of the building in Malagodi street n.8 in the center of Cento.
