# The Emilia-Romagna earthquake: Damages to precast/prestressed reinforced concrete factories

A. Marzo\*, G. Marghella\*\*, M. Indirli\*\*\*

**Keywords:** precast structures, factories constructions, seismic damages, Emilia Romagna earthquake.

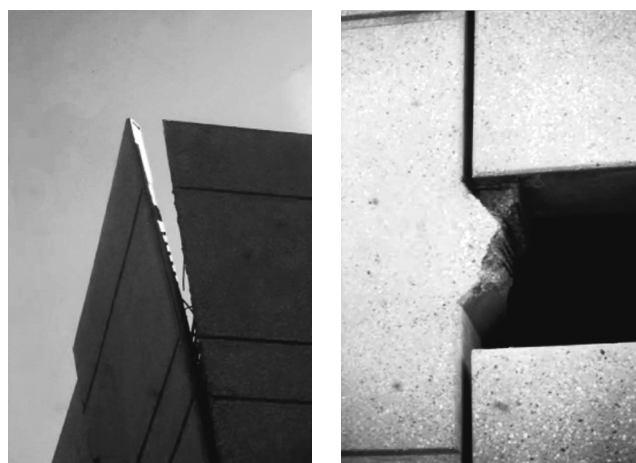
For example, after the January 17<sup>th</sup>, 1994 Northridge earthquake [Los Angeles, California, USA,  $M_w$  6.7, see EERI, 1994], several parking lots suffered widespread damage or collapse. Among others, a typical example was the Cigna Garage, a multi-storey assemblage of precast and in situ cast elements (Fig. 1), located at a distance of approximately 5.5 km from the epicentre (the closest recording station measured peak values of 0.47g, horizontal, and 0.30g, vertical). The building connections failed, due to loss of bearing of supporting elements [Bonacina, Indirli & Negro, 1994]. The Northridge earthquake clearly demonstrated the deficiencies in pre-1971 (i.e. the watershed date of the  $M_w$  6.6 San Fernando seismic event, which struck California in the same year) designed r.c. (including p/p.) structures. A large-scale revision of the code standards was carried out for various types of buildings in 1973, 1975, and after.

Fig. 1. Cigna Garage damaged by the 1994 Northridge earthquake (Bonacina, Indirli & Negro, 1994).

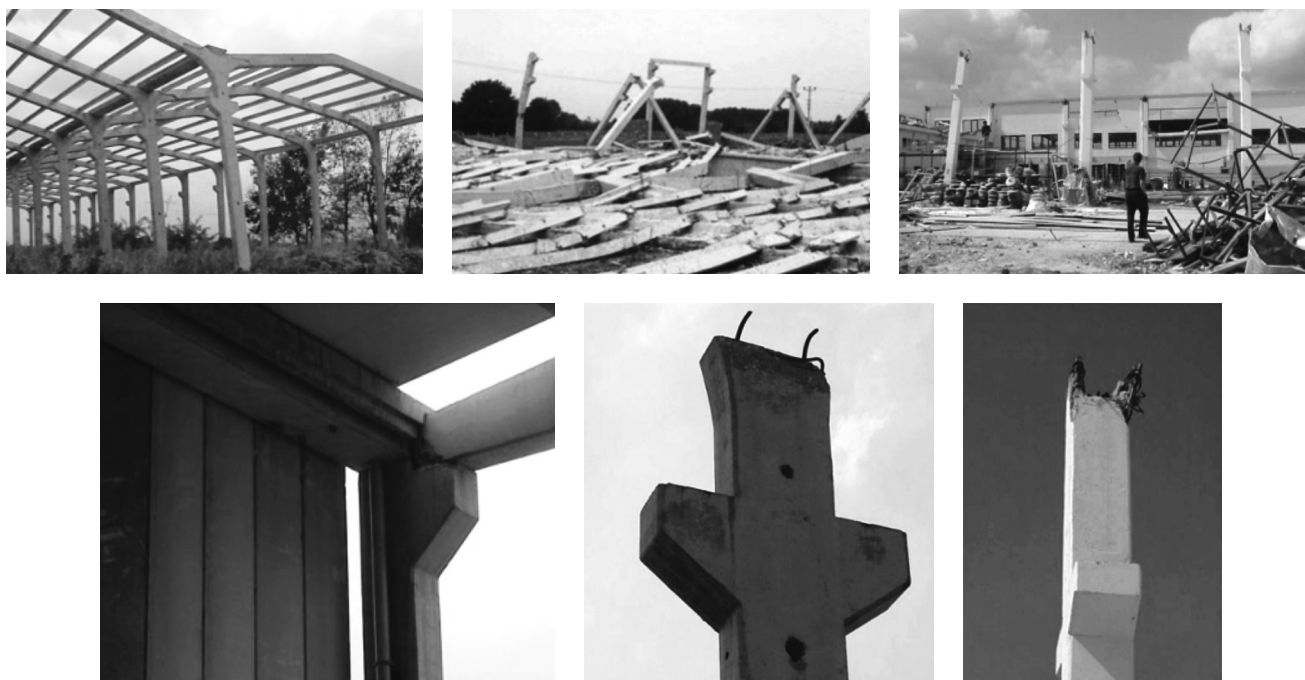
Fig. 3. P/p. r.c. structures, with different stage of construction and seismic behaviour located in the epicentral area of the Kocaeli earthquake (above) and details of the connections (below) (Saatcioglu et al., 2001).  
Costruzioni prefabbricate in c.a. con diverse fasi di costruzione e comportamento sismico localizzate nell'area epicentrale del terremoto di Kocaeli (sopra) e dettagli delle connessioni (sotto) (Saatcioglu et al., 2001).

epicentral area of the August 17<sup>th</sup>, 1999 Kocaeli earthquake [Turkey,  $M_w$  7.4, see EERI, 2000], didn't show good results, while others remained undamaged [Fig. 3, Saatcioglu et al., 2001]. The collapse was mainly due to poor design, detailing, and construction, leading to the lack of diaphragm action caused by the inadequate connections (pinned or dowel, simple to realize by the prefabricators) between columns and beams. In addition, buildings under construction were susceptible to collapse when the roof girders rotated off their supports [Posada and Wood, 2002; Doneux et al., 2006].

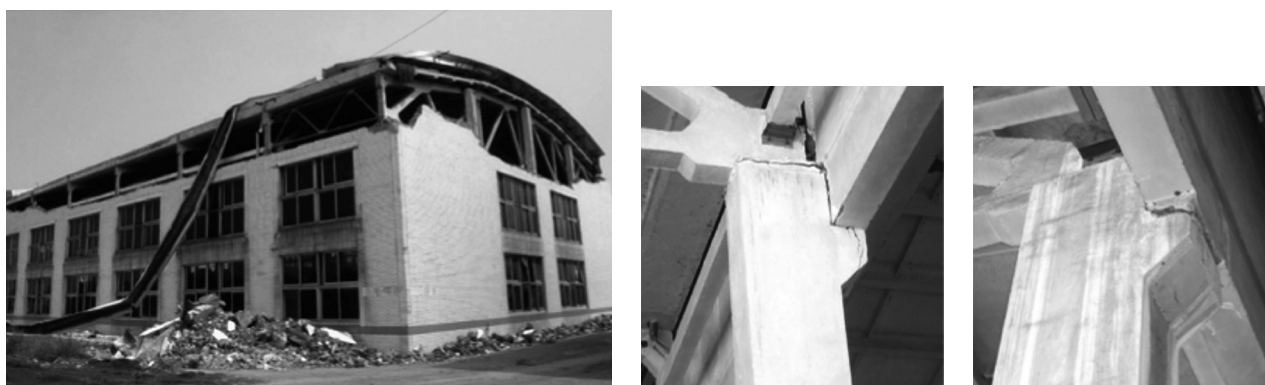
Fig. 4. Damage and partial collapse of the Xiting Package Ltd. Factory complex in Mianzhu City, Wenchuan, China, (Zhaoa et al., 2009).  
Danno e parziale collasso del complesso industriale Xiting Package Ltd in Mianzhu City, Wenchuan, Cina (Zhaoa et al., 2009).

Also after the May 12<sup>nd</sup>, 2008 Wenchuan earthquake (China,  $M_w$  7.9), industrial buildings and facilities, in the area near the fault rupture, were severely affected, as shown by Fig. 4 [Zhao et al., 2009].

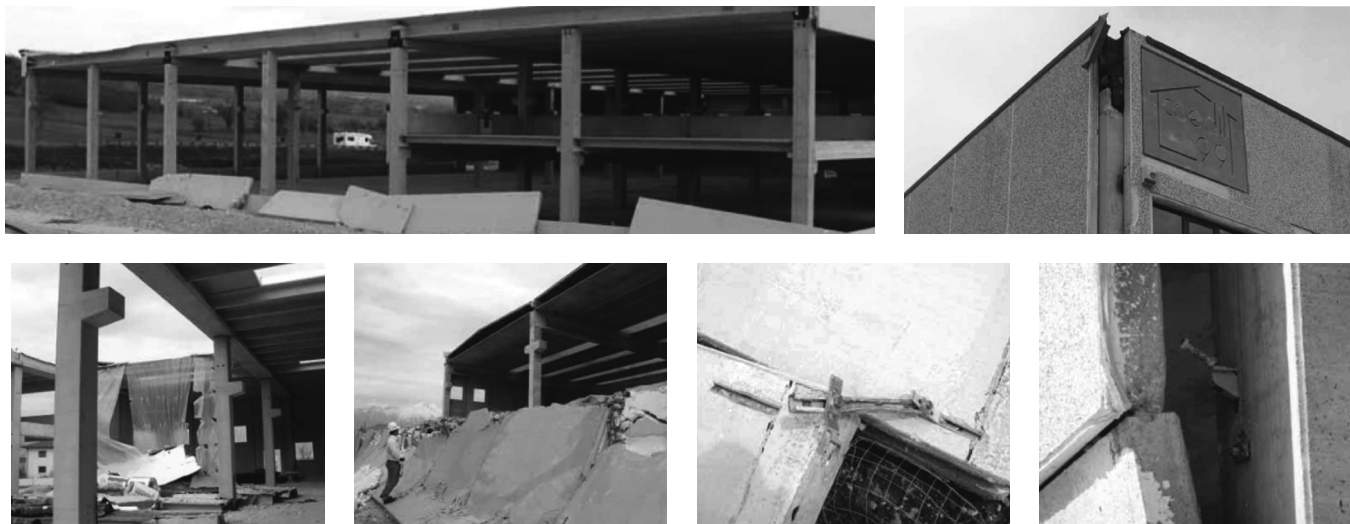
Fig. 5. *P/p. r.c. structures in L'Aquila lack of adequate anchoring led to collapse L'Aquila (Myamoto 2009).*  
 Strutture prefabbricate a L'Aquila; mancanza di adeguate connessioni hanno comportato il crollo (Myamoto, 2009).

The April 6<sup>th</sup>, 2009 Abruzzo earthquake (Italy,  $M_w$  6.3) again seriously affected some p/p. r.c. buildings, generally unanchored or inadequately braced; taking into account the relatively new vintage and the existing seismic classification of the area before the event, the level of damage was surprising [Fig. 5, Myiamoto, 2009].

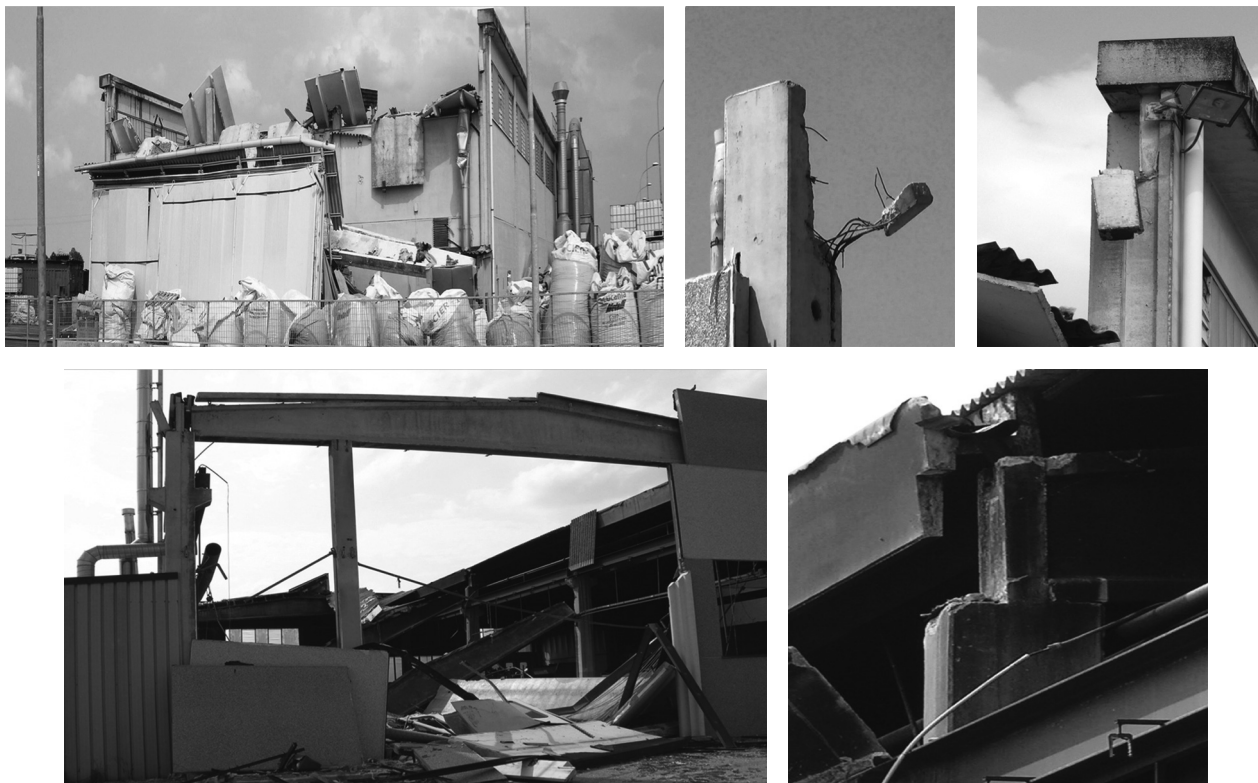
The more common collapse of p/p. r.c. single-storey buildings occurred because of the inadequacy of the supports of the horizontal structural elements (tiles and beams). In particular, the tiles fell down from the beams and the beams from the columns, due to the insufficient contact constraint. In fact, the horizontal forces have been transmitted thanks to friction only (tiles/beams simply supported by beams/columns respectively). In other cases, the presence of a mechanical connection, realised by a metallic pin, has been, in any case, unable to absorb the horizontal forces due to the seismic excitation, collapsing likewise (Fig. 8).

Fig. 8. Collapse due to the lack of supports: a) the breakdown of the upper fork; b) loss of support.  
Crolli per assenza di supporto: a) La rottura del collegamento superiore; b) perdita di sostegno.

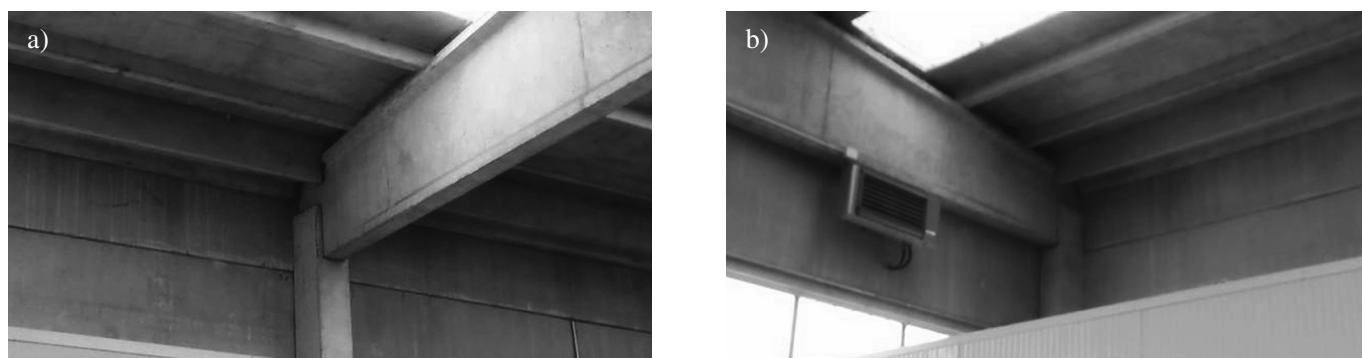
A noteworthy case of undamaged factory, located close to the collapsed structure shown by Fig. 8a, has been investigated by our team. It shows a similar construction system, but a significant difference in the constraint details, due to the shape of the covering tiles, realising a tile/beam connection, effective in the seismic direction as a tying system (Fig. 9). This fact demonstrates that a simple technology detail preserves the entire building.

Fig. 9. Undamaged structure: a) covering structure to beam connection; b) corner configuration.  
Struttura intatta: a) connessione trave copertura; b) configurazione d'angolo.

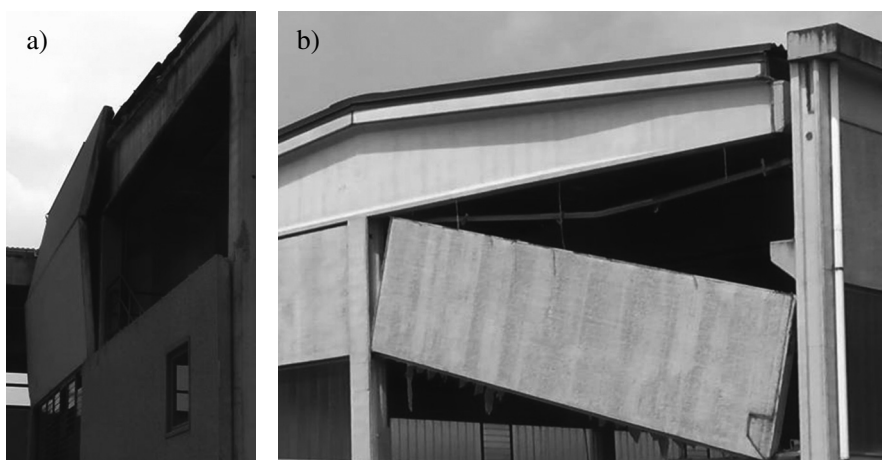
Fig. 10. Precast cladding: a) inadequate support; b) lack of the support.  
Facciate prefabbricate: a) supporto inadeguato; b) mancanza di supporto.

The p/p. r.c. cladding system is generally realized with r.c. precast (horizontal or vertical) panels. The connection types between panels and structural elements (beams or columns) are several. Among the damaged factories, the most common system is done with angle-steel or r.c. supports, the latter being realised by appropriate shaped columns or beams. The main cause of collapse is due to the inappropriate features of supports to absorb horizontal forces (Fig. 10). In addition, differential displacement between adjacent columns and hammering of covering versus columns caused the collapse of the cladding panels, because of the lack of the support.

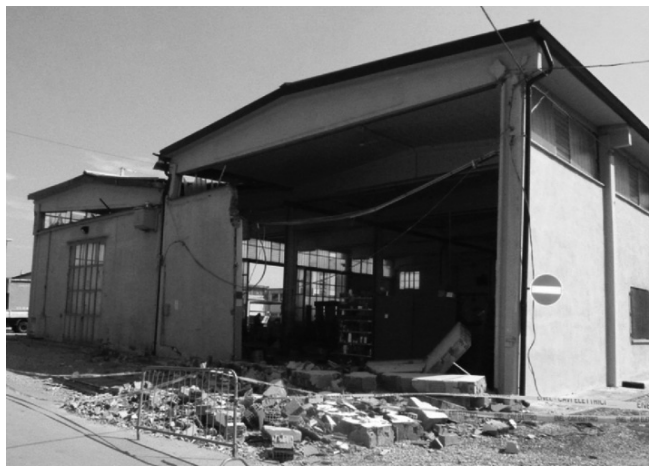
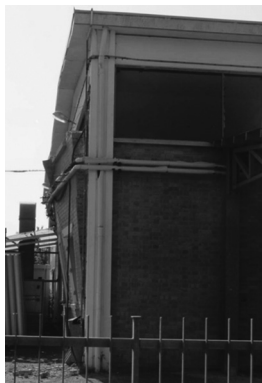
Fig. 11. *Solid brick cladding damage.*  
Danni a facciate in mattoni pieni.

Cladding made of solid brick is observed in the case of more recent simple-storey structures. In this case, the cladding suffered vast damages such as cracks (due to in-plane mechanism) or overturning (due to out-of-plane ones, Fig. 11).

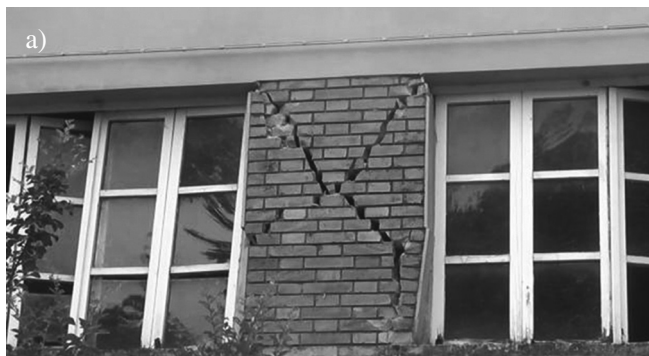
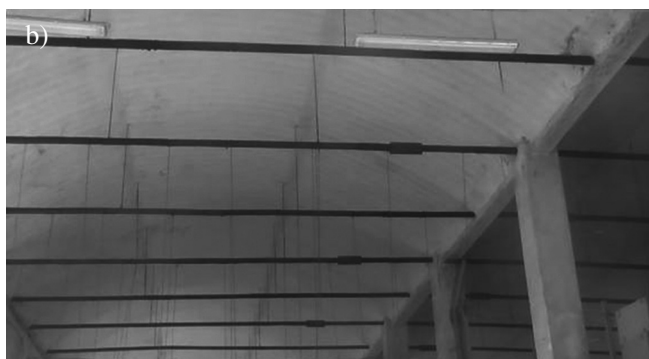
Fig. 12. *Mixed masonry-prestressed structures: a) reduced resistance piers; b) presence of steel ties.*  
Combinazione muratura-struttura prefabbricata: a) maschi di ridotta resistenza; b) presenza di catene.

Finally, mixed masonry-prestressed r.c. structures underwent damages due to the opening location (windows and main entrance), which significantly reduced

the resistance of the masonry piers (Fig. 12a). In the observed case, it is worth noticing that the presence of steel ties significantly enhanced the response against the seismic effects, thanks to the increase of the box behaviour (Fig. 12b).

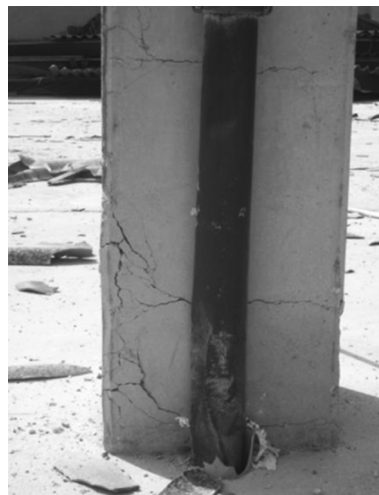
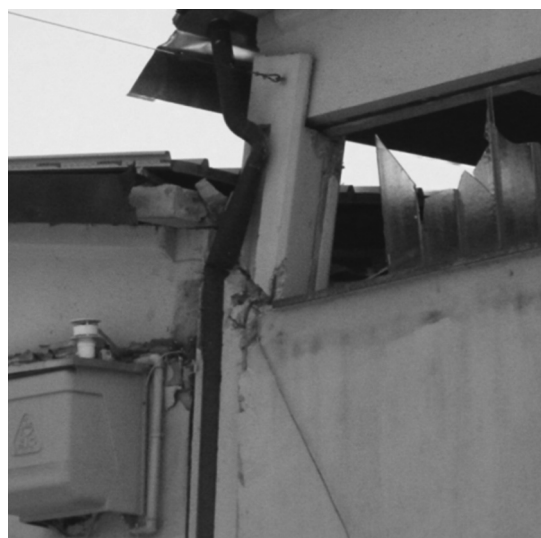
Fig. 13. *Column damages.*  
Danni a colonne.

Foundations are usually shallow and include precast r.c. isolation footing, in which the columns are framed. The upper end of the columns is generally unrestrained, as already said. Therefore, the structural scheme is represented by a cantilever element. Consequently, a plastic hinge often has formed at the base of the columns, when the seismic event occurred (Fig. 13a). In other cases, the column collapse has been due to the support failure (Fig. 13b).

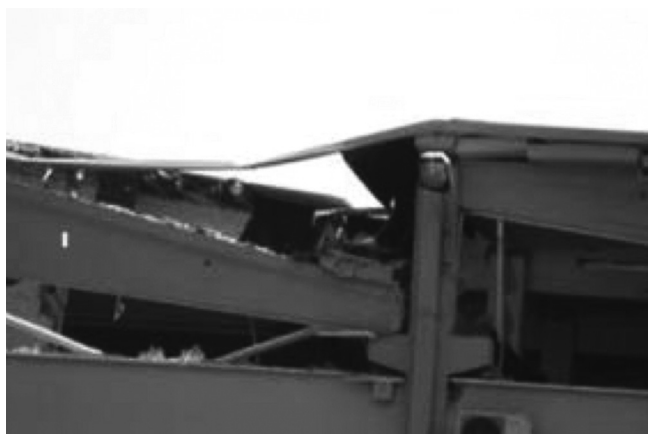
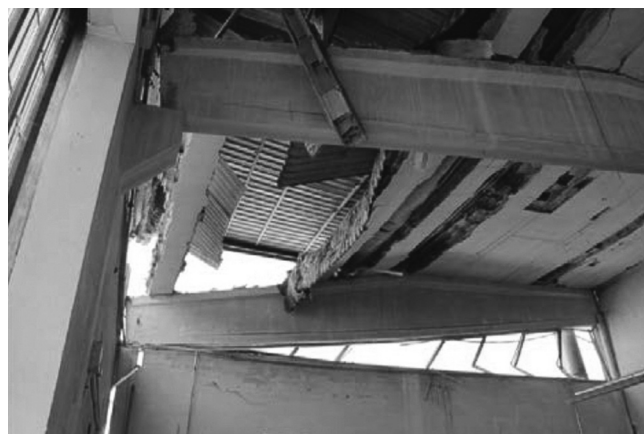
Fig. 16. Deficiency due to inadequate connections among structural elements (DPC, 2012).  
Problemi conseguenti connessioni tra elementi strutturali non adeguate (DPC, 2012).

All the structural elements (beams, columns, floors and foundations) should guarantee a box behaviour under the horizontal forces due to the earthquake. Friction connection is not allowed. The efficiency of precast linking system should be evaluated, while the resistant mechanism of the in situ casted r.c. connection systems involves both concrete and steel bars mechanical features. In the latter case, only the shear strength of the concrete can be considered, if the information about

steel bars is absent. According to the dimension of the support, specific interventions should be realized in case of absent or inadequate shear resistant systems, aiming at the reduction of both beam-covering and beam-column relative displacements (see Fig. 6a). At this purpose, the realization of steel connection systems can be useful to upgrade or retrofit the support perform in case of both sliding and fix constraints, thanks to their easy and speed in execution. Sliding connections should be designed taken into account the main seismic displacement (Fig. 19). On the other case, the fix constraints should not lead additional significant moments to the connected parts (beam and column) because they are not designed to perform this stress. Therefore, a hinge constraint was also suggested at the column-beam connection (Fig. 20a,c). The consolidation of the column forks can be realized by means of steel elements, similarly, where it is required (Fig. 20b). The decrease of the permanent load can be useful in case of upgrading of the shear connection strength. Covering structures can be suspended to an *ad hoc* system. In addition, the reduction of relative displacements in x direction (column-beam, see again Fig. 6a) should be also realized. In any case, it is necessary to carry out shear connection elements. Finally, vertical connection between structural elements should be realized by considering the results of in situ inspections, if the vertical seismic component can produce relevant effects.

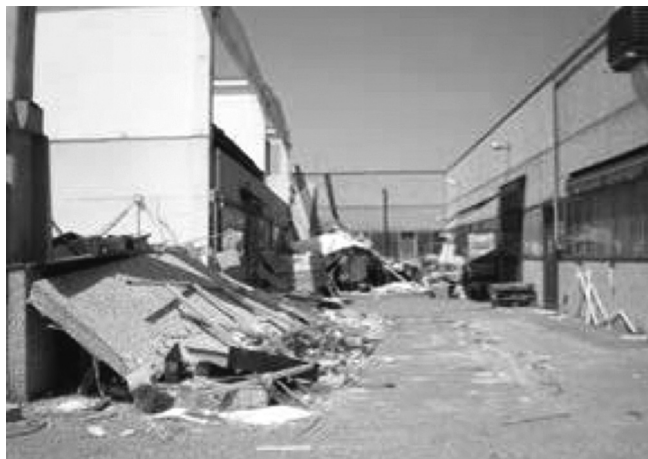
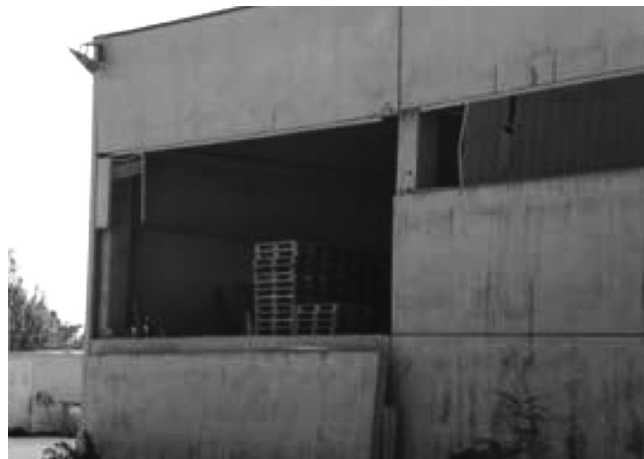
Fig. 17. *Deficiency due to inadequate connections between cladding panels and structural elements (DPC, 2012).*  
 Problemi legati a connessioni tra elementi strutturali e pannelli di facciata non adeguate (DPC, 2012).

In presence of seismic actions, any type of anchorage may be subjected to two different effects: the inertial action parallel or orthogonal to the panel plane; and the stresses arising from the deformability of the main structure, usually much greater than the panel deformability in its plane. The Decree (2012) recommends the structural engineer to focus his attention on the various typologies of connections, installed in the p/p. r.c. structures present in the affected area, because most of them have been designed by considering only vertical forces (or very low horizontal components). Moreover, these mechanical links often show an evident lack of flexibility, being connected to very rigid panels; subsequently, they are not able to sustain the displacements imposed by the earthquake to the building, resulting in brittle collapse. On the contrary, excessively resistant connections may originate local or global breakage. Therefore, the anchoring elements should have suitable resistance to out-of-plane action induced by the earthquake, sufficient shear strength in relation with the demand due to in-plane panel/structure interaction, and finally allow relative displacements between frame and shell. Plastic mechanisms can occur only if overturning mechanisms are avoided.

The most suitable interventions, related to the anchoring systems, are the following:

- increase of the number of the anchorage units, or substitution of the existing ones with more ductile new elements; in both the cases, the connection system resistance should be lower than the resistance of the connected elements (panels and structural parts);
- increase of the system bending capability, also introducing additional devices;
- limitation of the interaction between bearing structure and cladding panels.

An appropriate solution can be the removal of the band windows, contributing significantly to the reduction of the cladding vulnerability.

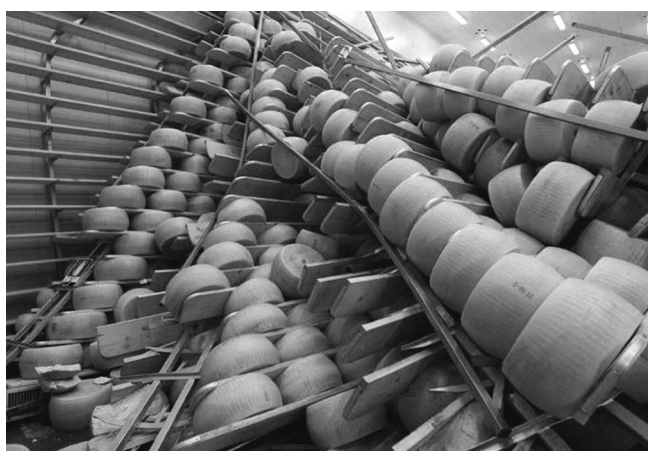
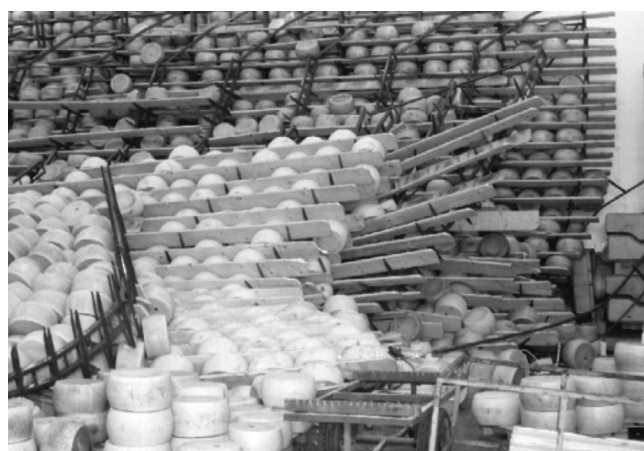
Fig. 18. *Deficiency due to shelf units without bracing.*  
 Crollo di scaffalature non controventate.

The Guidelines draft [DPC, 2012] considers also the risk due to the presence of metallic shelves, storing heavy materials, because they could lead to damage/collapse of structural parts under the seismic excitation.

In general, shelf units are made of steel cold formed profiles. The connection types are several and usually very weak. After a preliminary evaluation of damages induced by the seismic event on the whole structure and those caused indirectly by shelf elements, it is possible to assess the following requirements:

- the installation should be unconnected from the shelves;

- all the loaded planes should be equipped of fall protections;

In addition should be controlled the base of each shelf and the maintenance conditions.
