The Emilia Romagna, May 2012 earthquake sequence. The influence of the vertical earthquake component and related geoscientific and engineering aspects

Panayotis Carydis*, Carlo Castiglioni**, Efthymis Lekkas***, Irene Kostaki****, Nikolaos Lebesis*****, Alberto Drei*****

Keywords: Earthquake reconnaissance; Apennines-Po Plain seismotectonics; strong motion records; vertical seismic component; cultural heritage damage; prefabricated industrial buildings; rack steel structures.

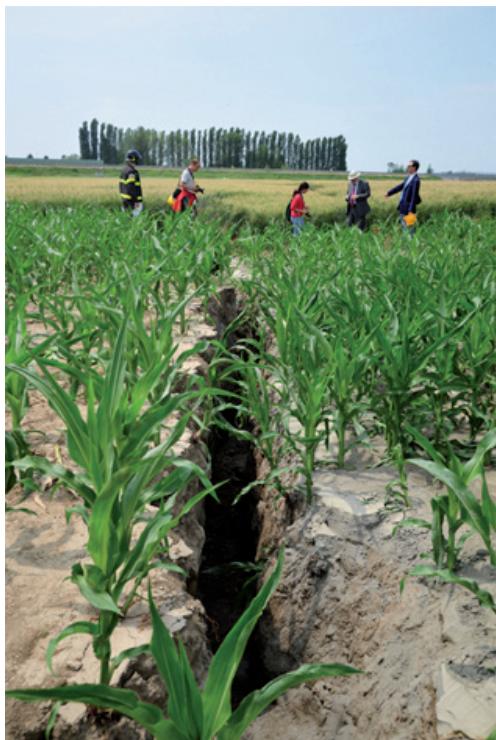
Fig. 11. ENE-WSW trending lateral spreading and liquefaction in San Carlo. Estimated ground crack length 300m. Maximum opening of 1m and vertical offset of 0.5m.

Ground cracks with great amounts of ejected liquified sand on the field and water fountains as high as 1.5m were observed by local residents at the time of the 20th May 2012 earthquake event, and suggests that the material was ejected with high pressure, higher than usually observed at events of this magnitude and depth. This concludes that the liquified zone is located at a lower depth than usual, around 10m as suggested by local geology (Figs. 11-15).

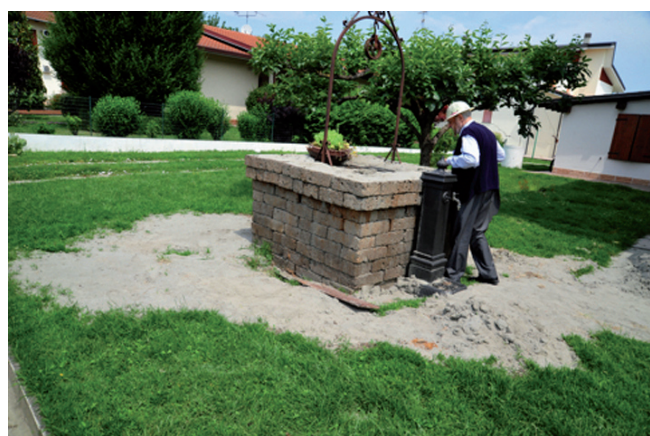
Fig. 12. Well with liquefied sand deposition due to violent ejection in San Carlo.

Due to the same liquefaction and pressure augmentation mechanism, liquified material ejected violently from wells, as seen in Fig. 12. Due to the greater depth of liquifiable formations, no great damage was observed on the area, in contradiction with Adapazari liquefactions (Izmit 1999-Turkey) and Christchurch liquefactions (New Zealand – 2011). This great differentiation in damage pattern and degree is observed due to a) the amount

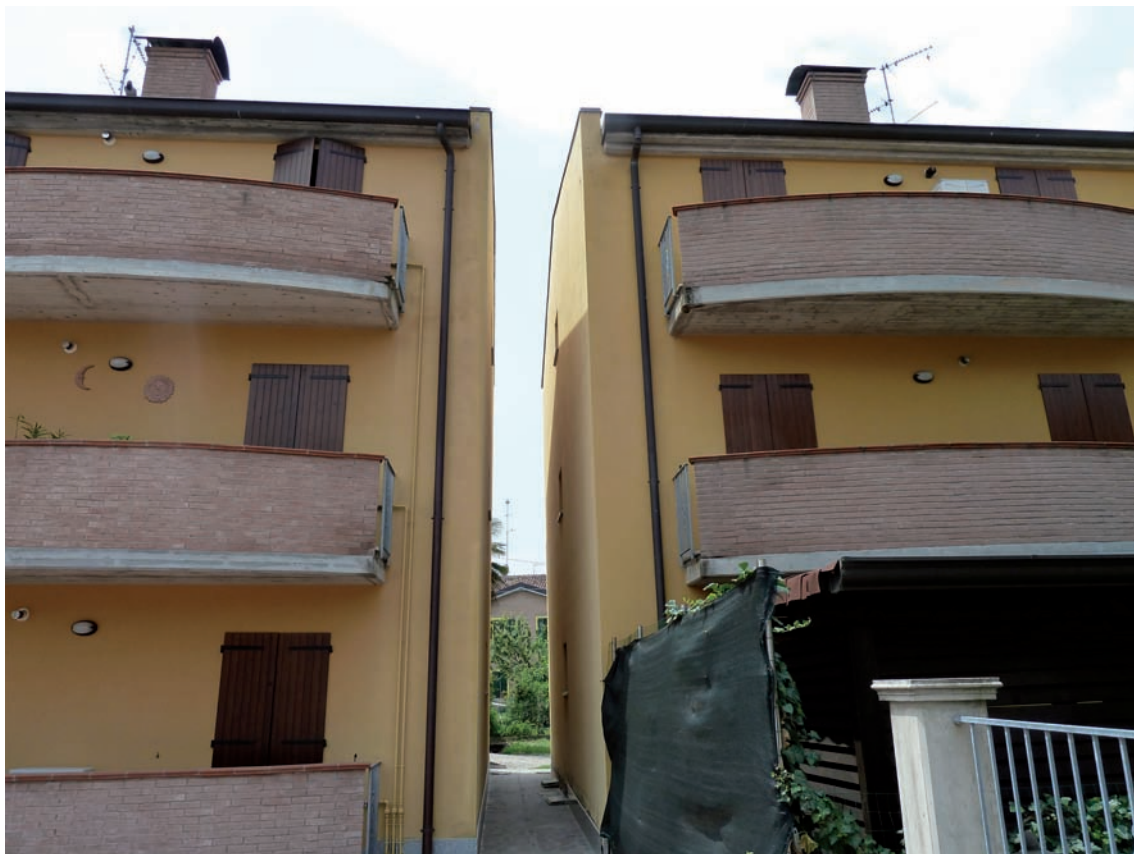
The only reported damage is a geometric deformation of two neighbouring buildings that were found to have tilted one against the other, as rigid bodies and without other apparent damage as shown in Fig. 16. So it is proved that the liquefied material in deeper formations actually functioned as a kind of base isolation absorbing seismic energy, as already mentioned.

Fig. 16. *Rigid body motion of two neighbouring buildings that tilted one against the other. The buildings did not show other apparent damage.*
Moto rigido di due edifici confinanti, che si sono inclinati uno verso l'altro. Gli edifici non mostrano segni apparenti di danni.

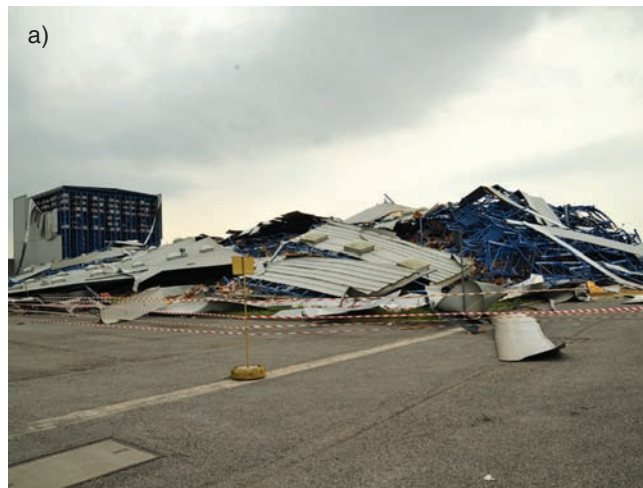
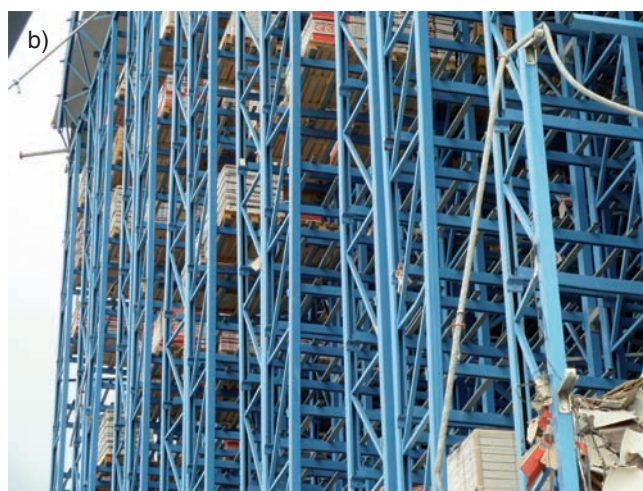
Fig. 18. a) A part of the ceramic warehouse in Sant'Agostino totally collapsed; b) This part of the same warehouse did not move. This can be very well justified by the relative position of the stored material to the steel members of the racks, which is in all positions the same. It must be taken under consideration that the positioning of the stored materials is computerized.

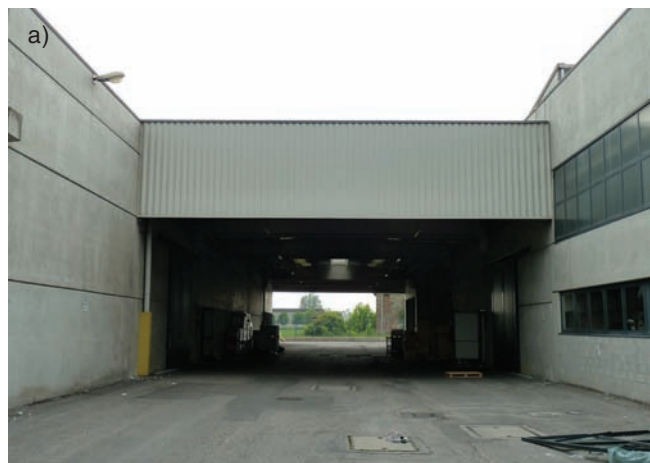
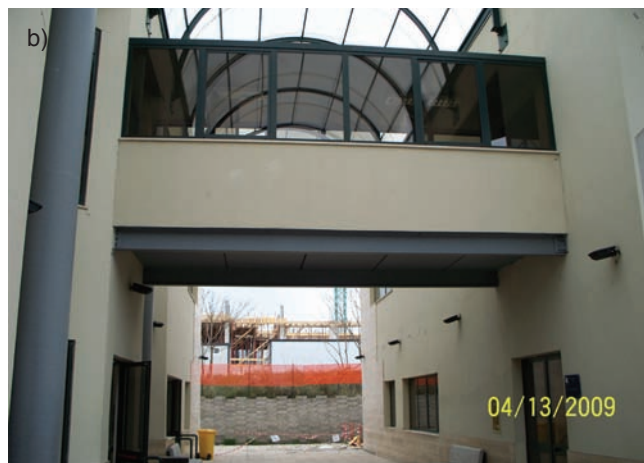
Fig. 19. The differential horizontal motion between neighboring structures is usually expressed by some damage in the bridging structure and the connecting parts; a) in the ceramic factory in Sant' Agostino and b) in the University of L'Aquila after the 2009 earthquake. At both cases not any sign of differential horizontal motion was noticed.

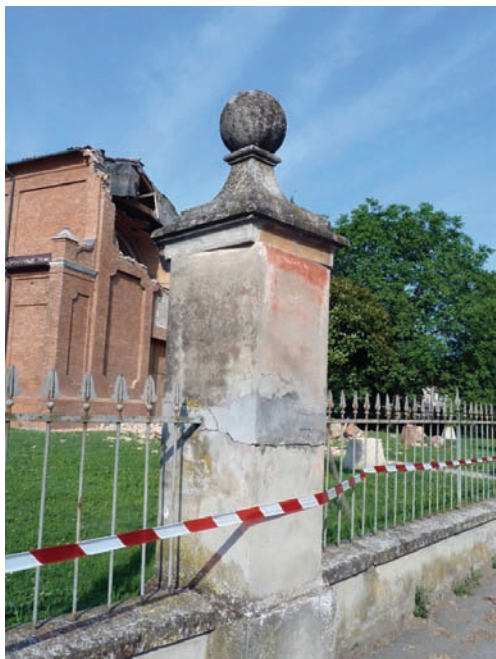
Fig. 22. The sculpture has not any horizontal translation; only torsion due to unsymmetrical friction at its base. Its dimensions are quite small to attribute this motion to any peculiarity of the horizontal ground motion. La scultura non mostra segni di traslazione orizzontale, ma esclusivamente torsione a causa di un attrito non simmetrico alla base. Le sue dimensioni sono troppo piccole per poter attribuire questo tipo di spostamento a qualche peculiarità del moto orizzontale del terreno.

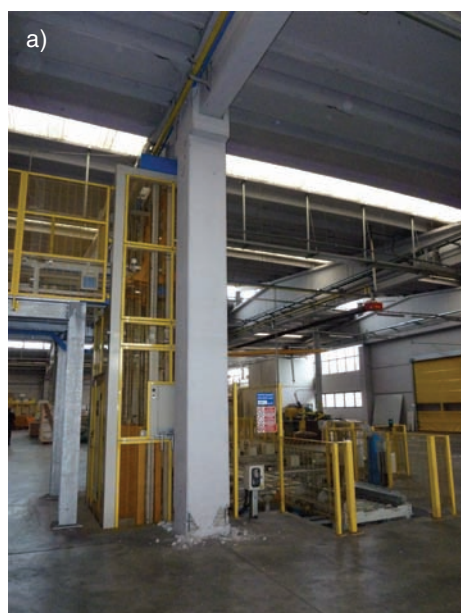
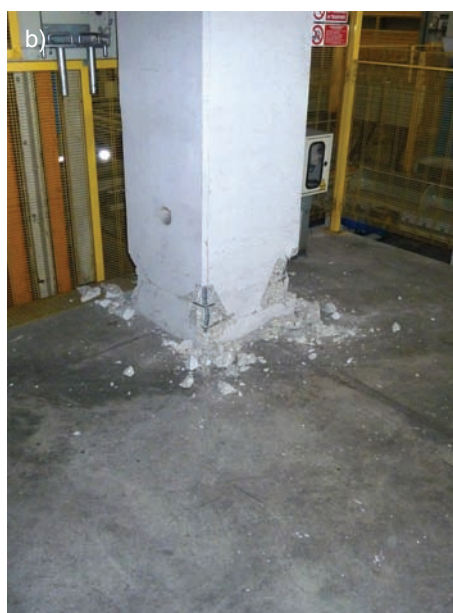
Fig. 25. a) A reinforced concrete structure, in Sant' Agostino ceramic factory, the only recorded damage was around the base of almost all its internal columns; b) There is no shortening of the column at the point of impact. Apparently the damage was caused by tension. Due to this tension the intensity of the impact is augmented, because of the stored energy in the reinforcement.

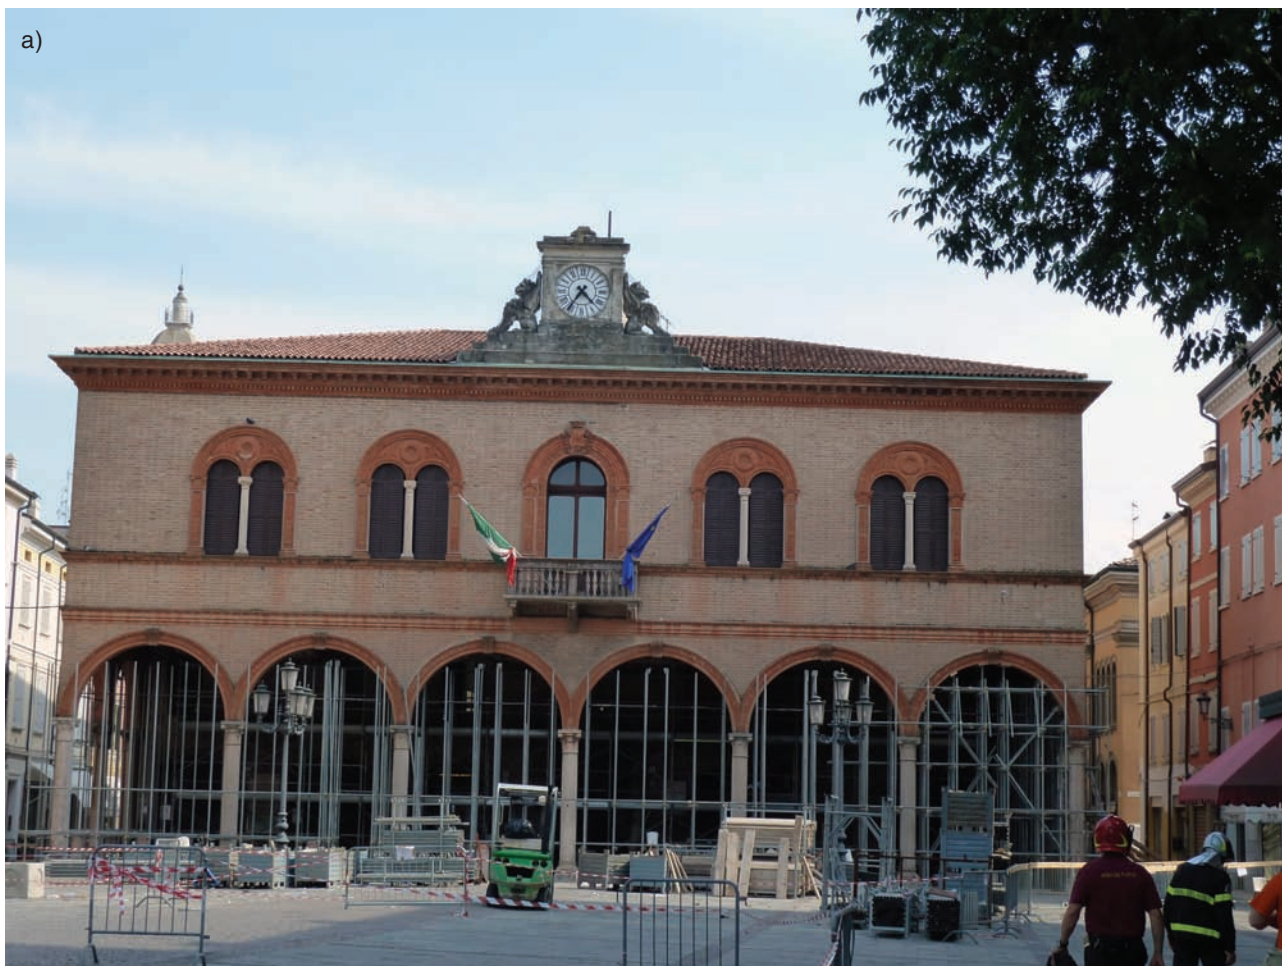
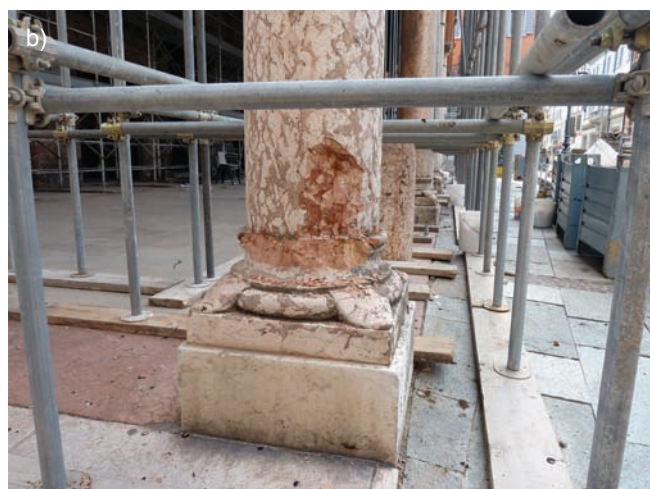
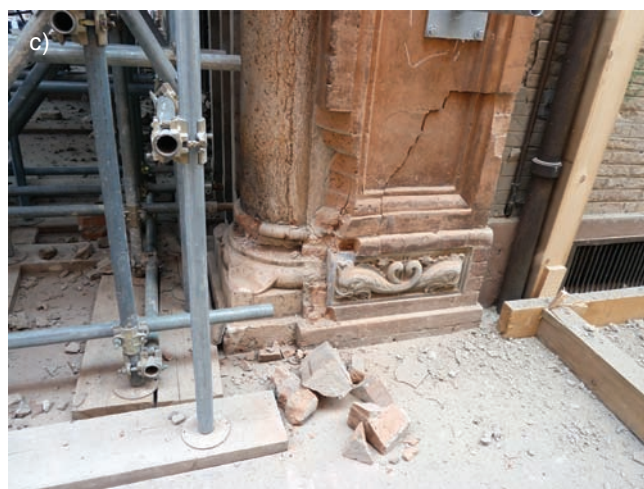
Fig. 26. The Mirandola Town hall; a) no major damage is noted by a rapid optical survey from the exterior, except the damage shown in b) and c) at the bottom of the masonry columns due to impact.

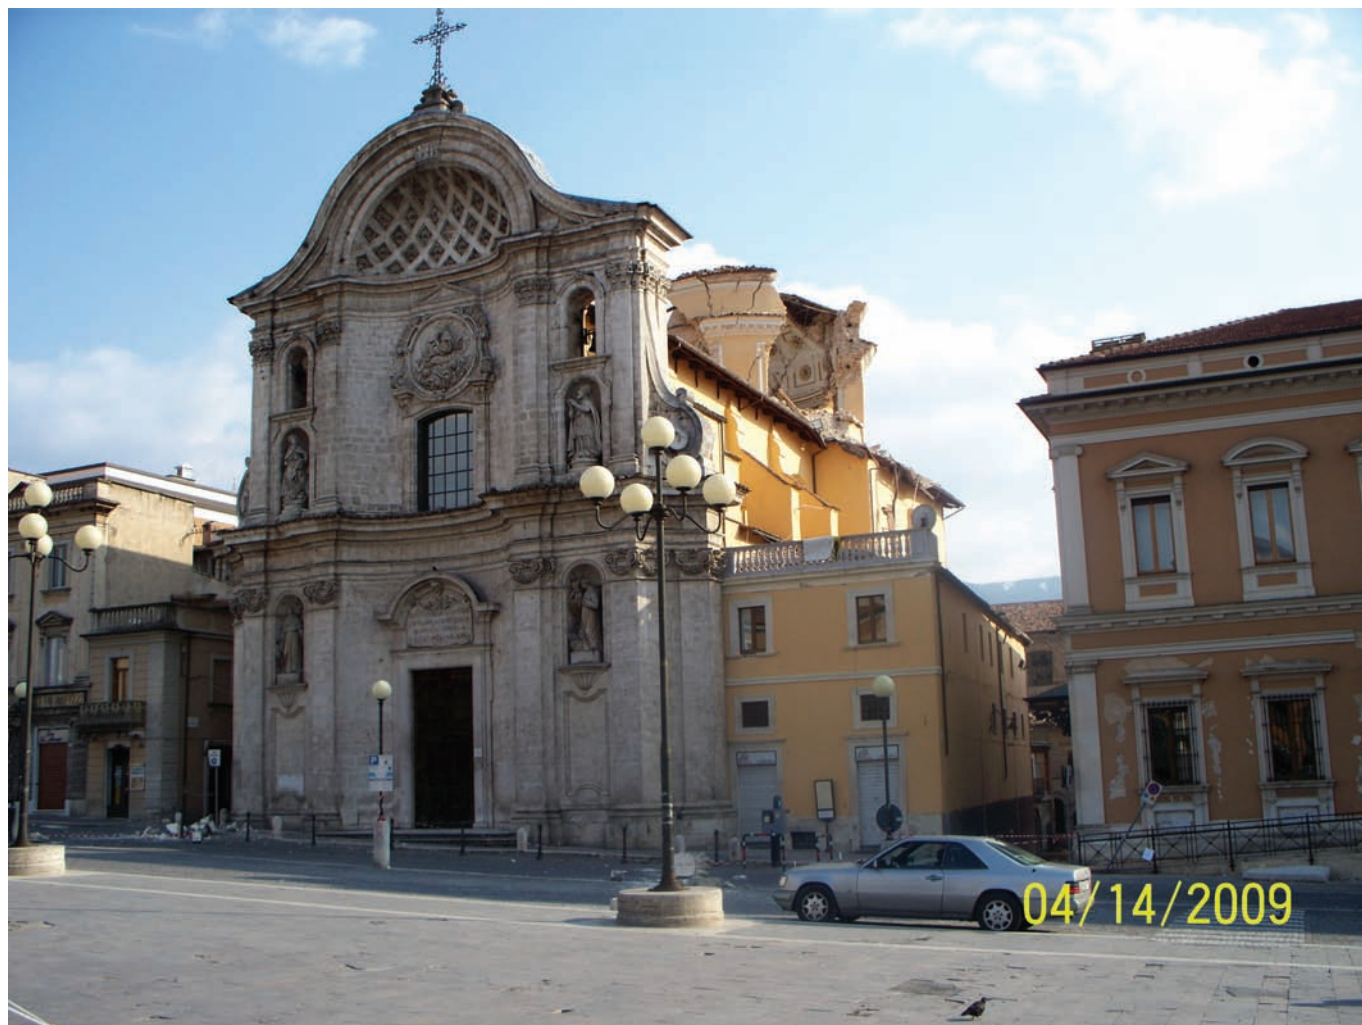
An other example is given in Fig. 27 in which the dome collapsed vertically within its plan. This type of damage is a trademark of the presence of a strong vertical earthquake component.

Fig. 27. Vertical collapse within the plan of the ground floor of the dome of Duomo church in L'Aquila, after the 2009 earthquake. There is not any other noticeable damage. Glass window panels are intact.

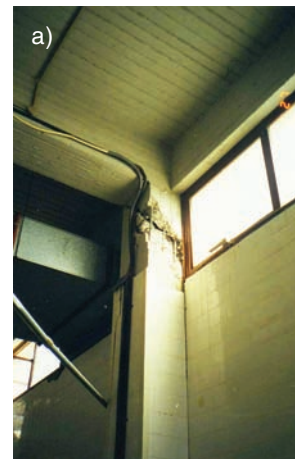
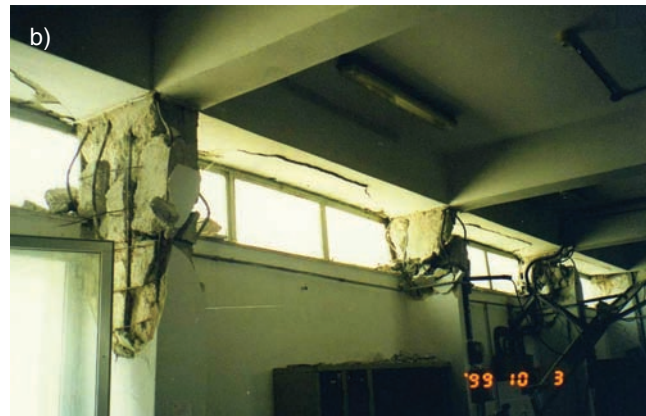
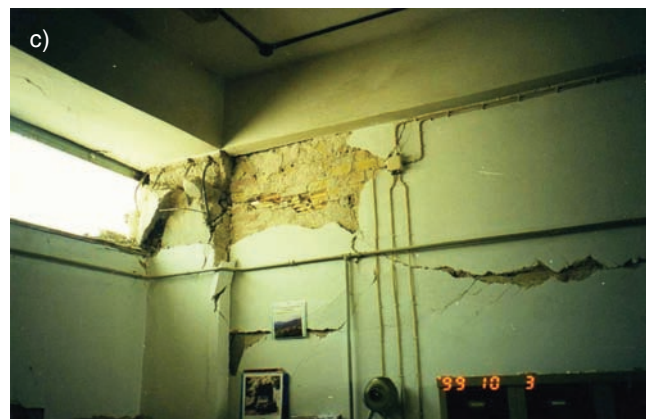
Fig. 29. "Short column", under a vertically propagated body wave action. The braking plane is perpendicular to the plane of the concrete wall and the respective beam. The adjacent window glass panel is unbroken. Not any significant residual vertical shortening is noticed. In c) the presence of a masonry wall perpendicular to the plane of the concrete wall did not prevent the break of the "short column".

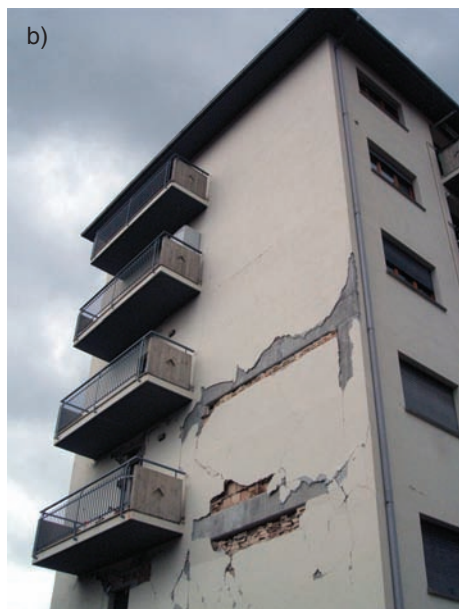
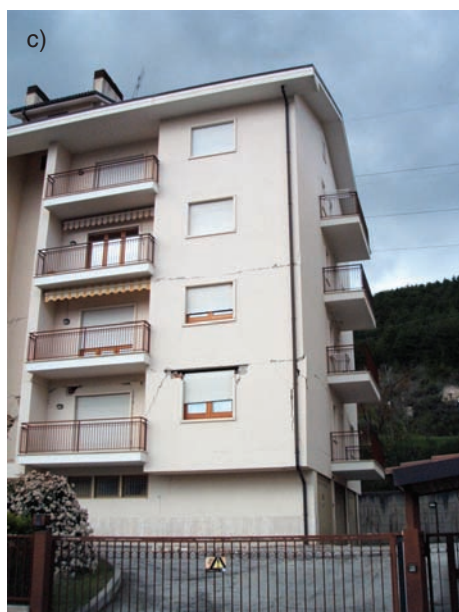
This fact explains the causes of horizontal cracks observed in many buildings (e.g. in L'Aquila after the 2009 earthquake as shown in Figs 30b and c), at the lower floor levels, eventually at the interface between r/c beams and masonry infills. A probable explanation is based on: a) the dynamic difference between a r/c beam (and as we can see of a considerable length) and a brick wall and b) the impact phenomenon on this type of structures, seems to be stronger at their lower floors. At the building of Fig. 30c, the damaged façade

Fig. 30. a) Additional vibrational effects on floors and roofs from the vertical earthquake component. Usually in most cases, the walls above the floor or roof level are toppling inside the building. This means that the fall is due to upwards motion of the supports (perimetric walls); b) and c) Damages observed in Pettino (L'Aquila) after the 2009 Earthquake
a) Effetti delle vibrazioni sui solai e le coperture, a causa della componente verticale del sisma. Nella maggior parte dei casi, i muri al di sopra del livello del solaio o del tetto ricadono all'interno del perimetro dell'edificio. Ciò significa che la caduta è dovuta al moto verso l'alto degli appoggi (muri perimetrali); b) e c) danni osservati a Pettino (L'Aquila) dopo il terremoto del 2009.

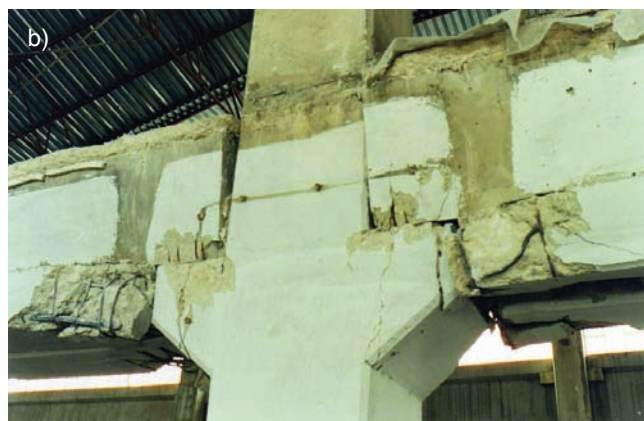
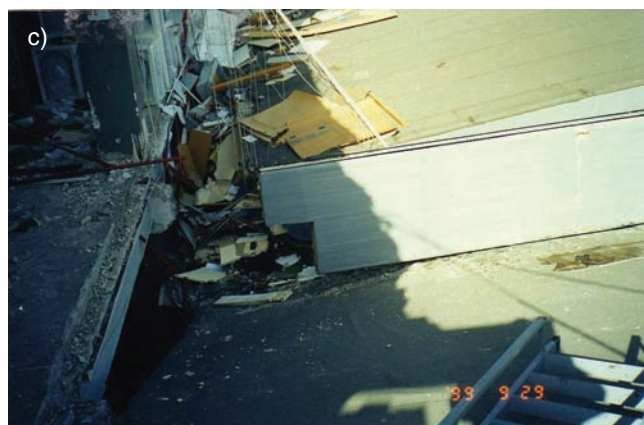
Fig. 31. a) Due to the vertical seismic component, the beam is jumping up and down on its supports if it is not sufficiently anchored; b) the corbel or the beam, or both are broken. In this case a vertical bolt is provided but it was too short and the beam jumped over; c) if there is a horizontal motion too, the results are worsened.

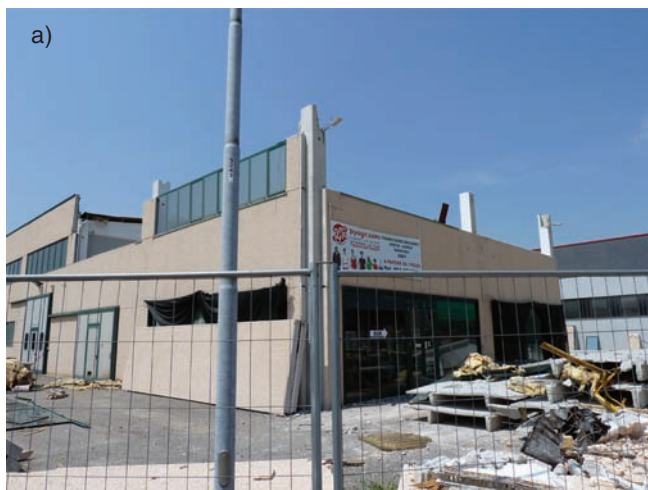
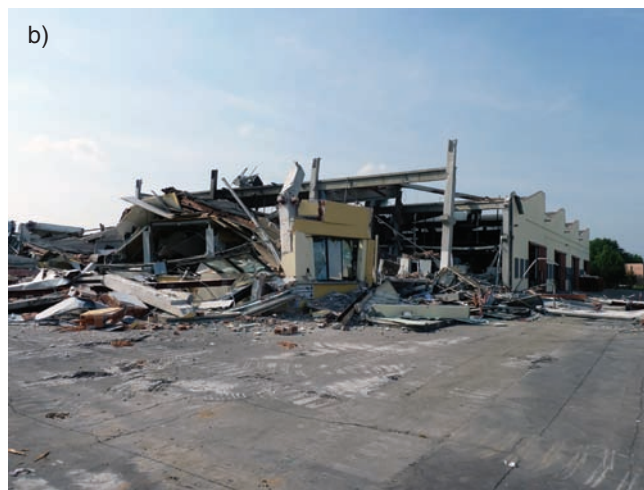
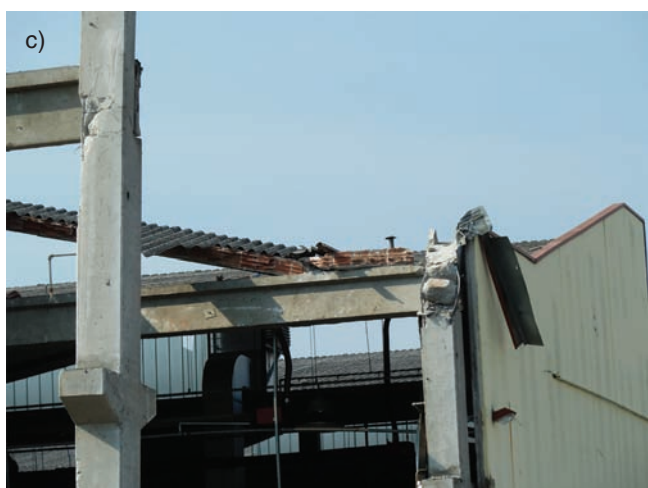
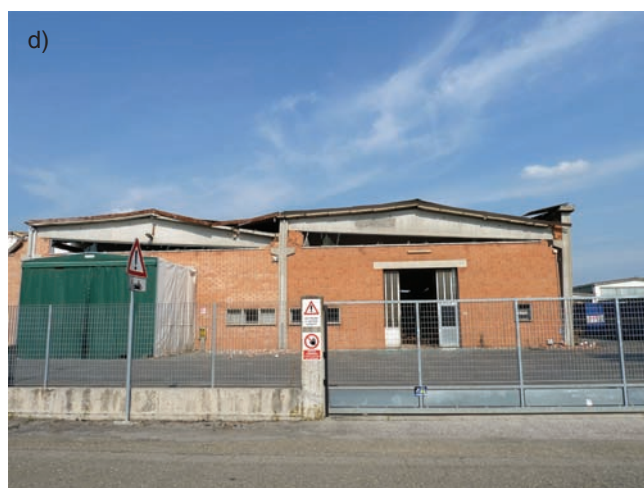
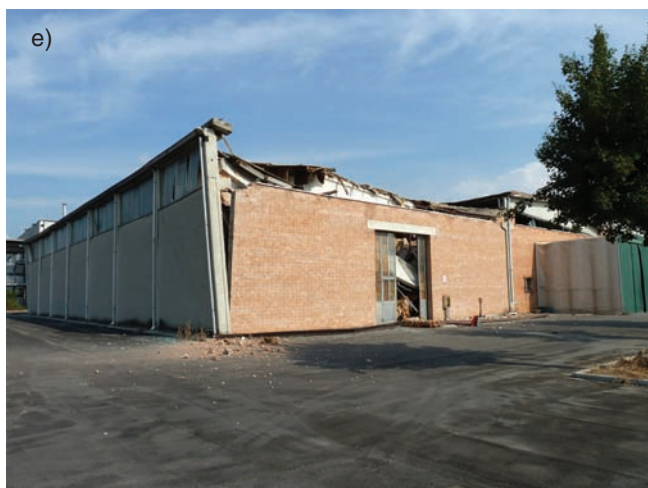
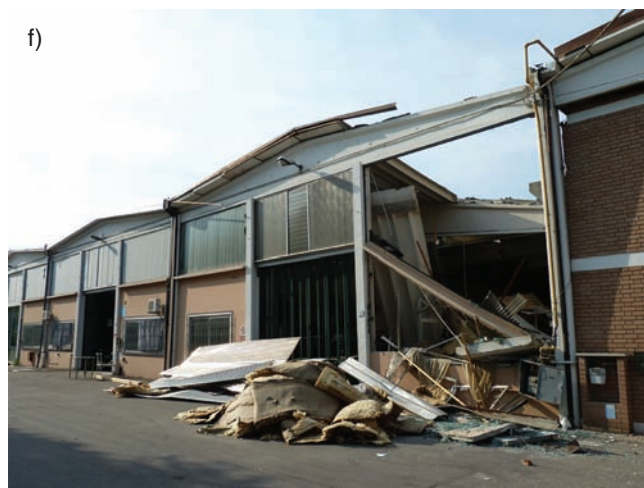
The lack of those provisions in the supports might be the basic reason for the numerous damages and collapses of industrial buildings' roofs made with prefabricated beams as it is shown in Figs. 32a to f. On the other hand, if any kind of beam to column joint was provided the response of the vertical element would be ameliorated. After that, we may conclude that structures, as the prefabricated ones, that are going to be applied in great numbers, must be designed for a higher degree of importance, than the one presently considered in Seismic Design Codes.

Fig. 32 a to f Simply supported prefabricated beams for the roofing systems and without any reliable anchoring were subjected to a combination of a very strong-impact-type-vertical component with a strong horizontal one. Those images of destruction are typical around the epicentral region.
Travi di copertura prefabbricate in semplice appoggio, prive di collegamenti affidabili, soggette alla combinazione di una forte componente sismica verticale e di una forte componente sismica orizzontale. Immagini di danni di questo tipo sono caratteristiche delle zone epicentrali del terremoto.

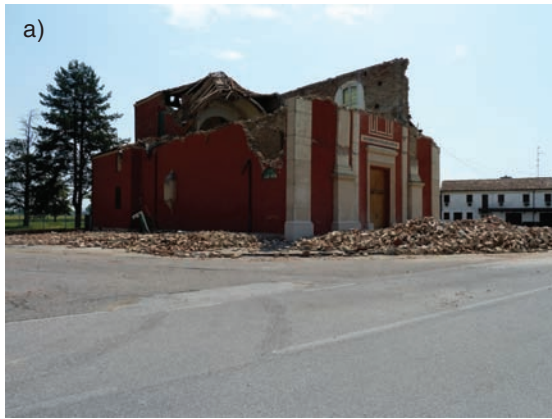
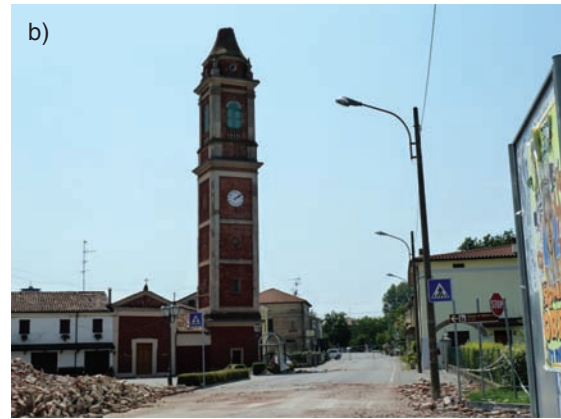
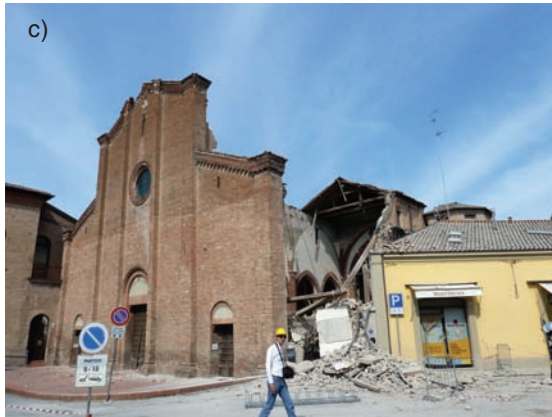
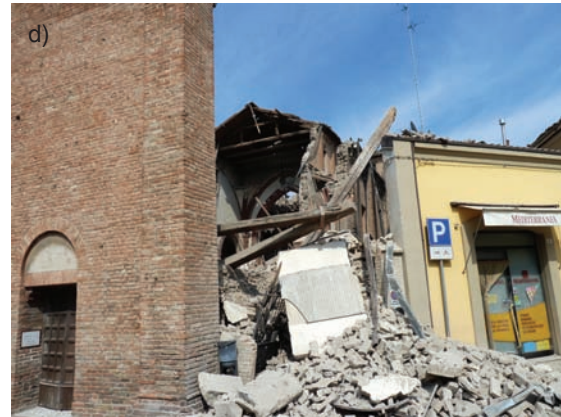
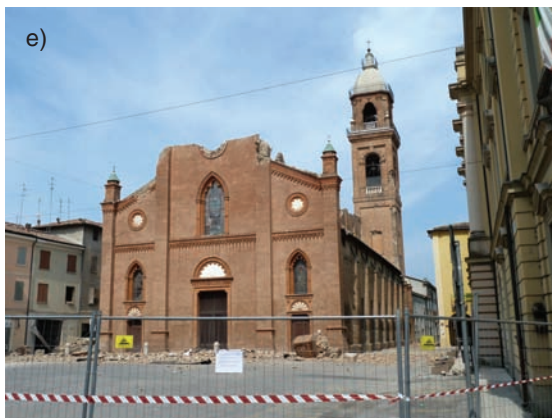
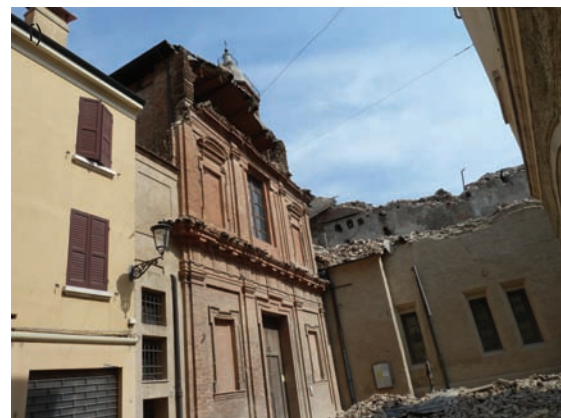
The incurred damage on churches in its main lines follows an almost identical pattern of failure mode: in most cases the western part of the church is damaged, and especially the respective roofing system collapsed. A representative selection of damaged churches is shown in Fig. 33a to h. In most cases, the western façade consists in a rather tall wall, that could be con-

A typical response of the bell towers is shown in Figs. 33b, e and h, in which the top of the spire was damaged. Some minor damage is observed on the rest of the body of the bell tower along the height and

Fig. 33. The incurred damage of churches follows almost an identical pattern. The bell towers survived with only minor damage along the height. In most cases the top of the spire was damaged; a), b) church of San Marino at Buonacompra; c), d) church of San Francesco at Mirandola, very heavy damage. The bell tower collapsed after the second event; e) Santa Maria Maggiore, Cathedral of Mirandola; f) a view from the north towards S-E; g), h), two damaged churches in Mirandola.

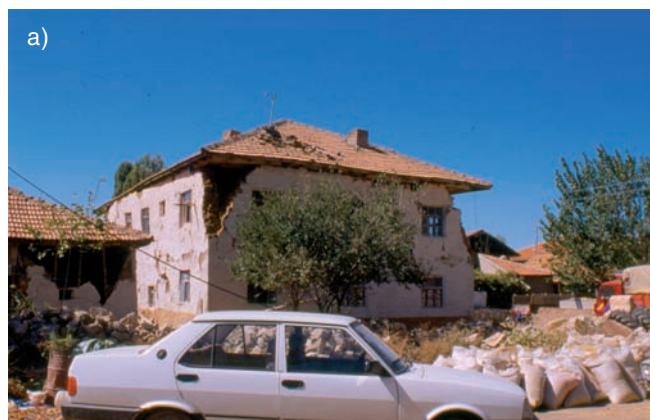
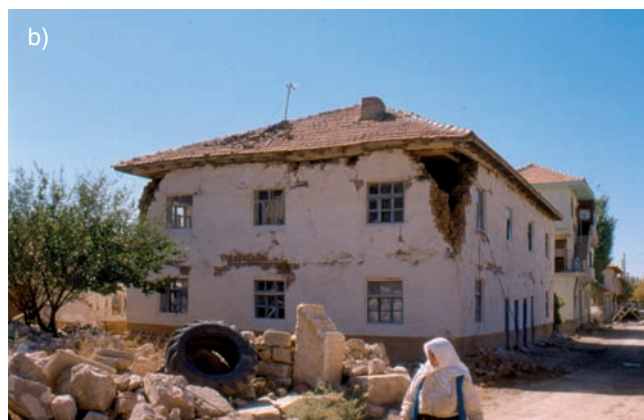
Figs. 35 a, b The damage to symmetrical masonry structures are symmetrical around the vertical vector. The well known diagonal cracks are not developed. The horizontal cracks at roof and first storey levels are due to vertical vibration of the roof and floor respectively. Typical is the detachment of all four top corners around the building. Dinar, Turkey, 1995 earthquake, /14/.

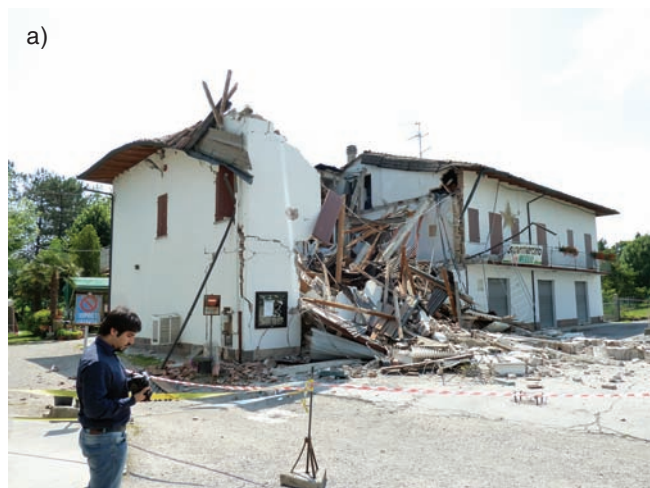
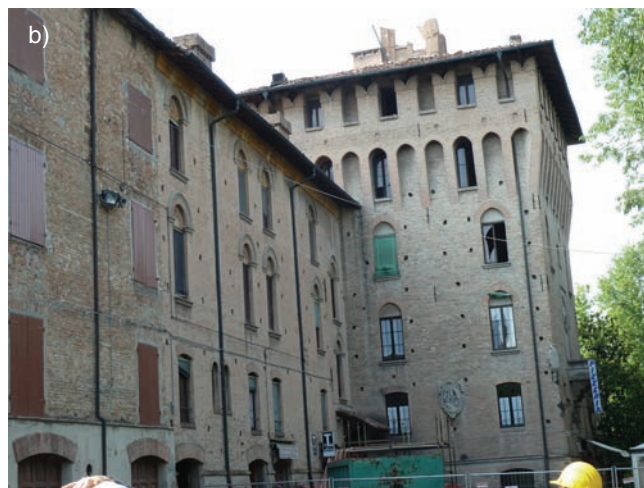
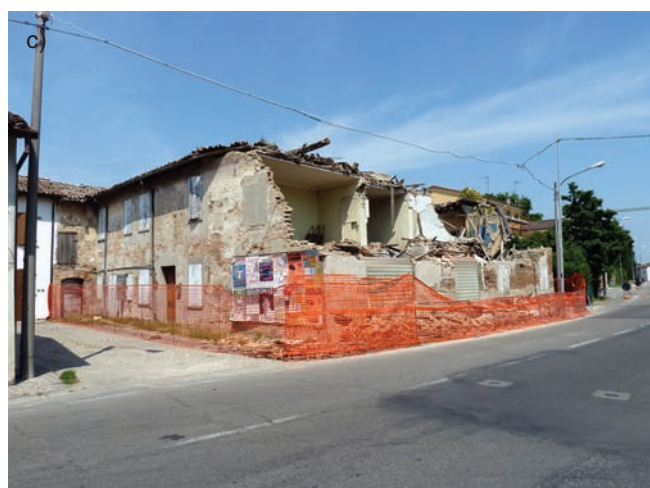
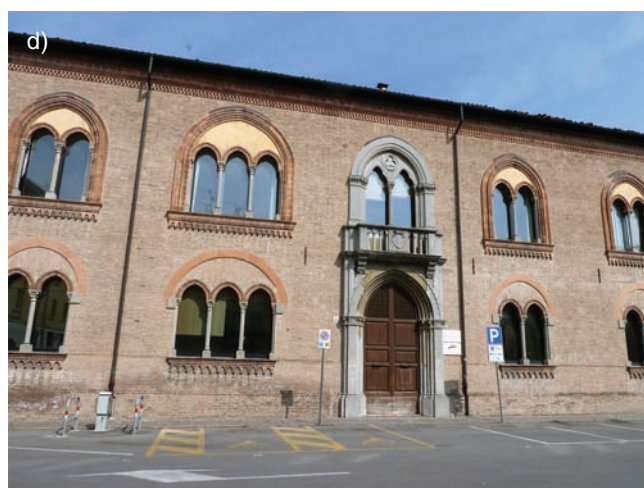
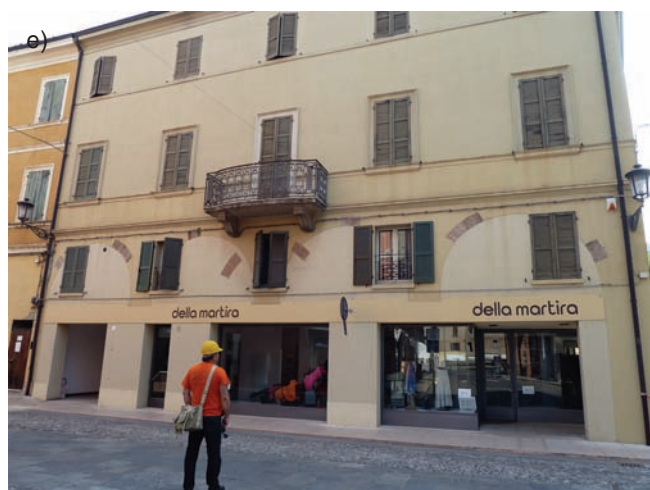
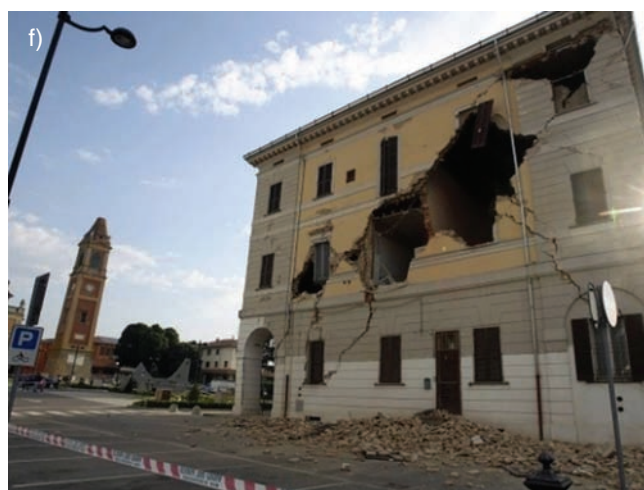
Fig. 36. A selection of representative damage incurred in masonry buildings as well as undamaged buildings. Each one of those deserves a special in depth investigation.

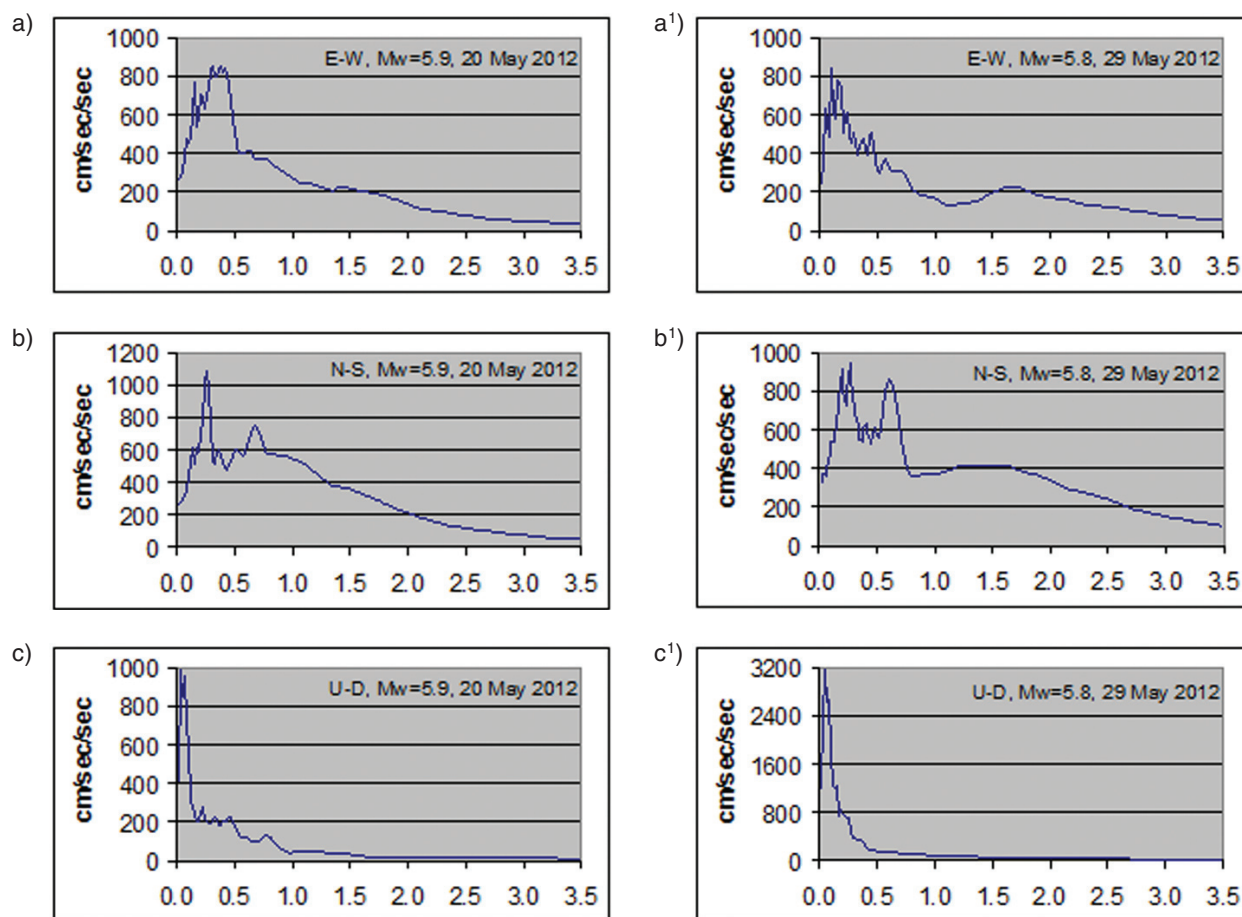
Fig. 38. Acceleration response spectra for the records presented in Fig. 37 and for $\zeta = 5\%$, a), b) and c) for the first event and a'), b') and c') for the second event, after /17/, /18/, /19/, /24/ and links.
