CHARACTERISATION TESTING OF MORTAR JOINTS USED IN PRECAST WALL-SLAB-WALL STRUCTURES

E. Brunesi^{1,}, S. Peloso¹, R. Pinho^{1,2}, R. Nascimbene³*

¹EUCENTRE, European Centre for Training and Research in Earthquake Engineering Via Ferrata 1, 27100 Pavia, Italy

KEYWORDS: *precast wall-slab-wall structure, wall-foundation connection, wall-wall connection, high-strength mortar, bond wrench testing, triplet testing*

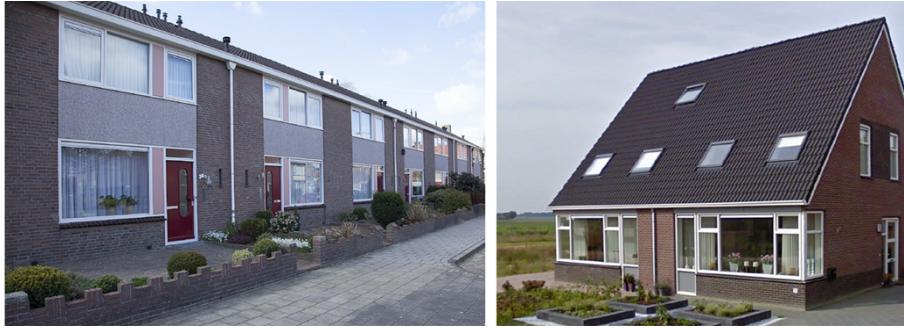
Figure 1: Typical precast concrete houses [12]

As can be gathered from Figure 1, these precast wall-slab-wall structures, which are mostly employed for housing in the Groningen region and more in general in the north of the Netherlands, consists of low-rise, single-unit or multi-unit buildings, typically single-storey or two-storey houses that are highly-standardised in terms of both building system and construction process [12]. According to Dutch building practice, these houses feature precast floors, precast party/gable walls and precast load-bearing walls in the longitudinal and transverse direction, with the installation process of both wall and slab panels that is initially crane-driven and then handled manually by the builders such that the panels are finally set in place.

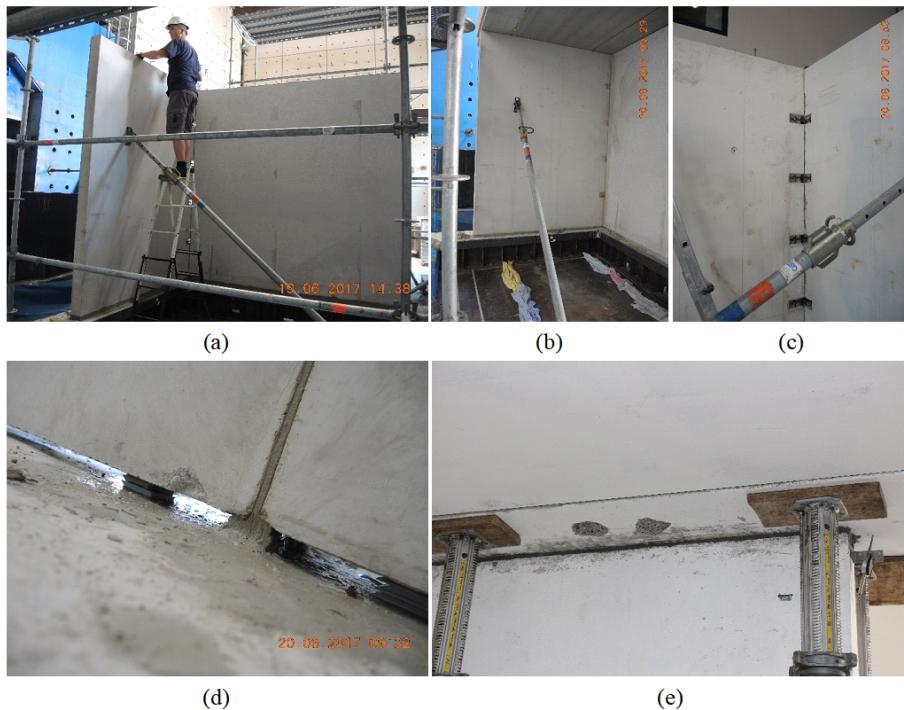
*Figure 2: Construction details concerning the installation of precast panels and the execution of mortar joints – adapted from Brunesi *et al.* [8]*

As an example, Figure 2 shows the installation of the first-storey shear/stability and transverse walls of a full-scale two-storey house tested at Eucentre [8]. Particularly noteworthy is the absence of steel rebars protruding into/from the walls (i.e. neither starter rebars are present at the base of the ground-floor walls, nor rebars pass through the floor to connect the first- with the second-storey walls), meaning that the base wall connections are simply high-strength mortar

joints. In the construction of these structures thus, firstly, the walls are seated onto 2-3 cm thick plastic spacers placed in-between their base and the foundation (or the hollow core slab), and the panels are held as upright as possible before steel diagonal props are installed temporarily to shore them up. Then, the steel connectors are lodged into the sockets that form once the two adjacent and the orthogonal wall panels are set in place. Finally, the base wall and wall-wall joints are executed, filling-in the interspace at the base of the walls and the connectors' sockets with high-strength mortar. After such operations are completed, the slab panels are settled onto the walls using fabric felts as interface material and the process is repeated for the upper storeys.

These key construction details, which are inevitably quite unfamiliar to building practice in countries prone to tectonic earthquakes, are collected in Figure 2a-e, whereas interested readers are referred to [8, 13] for more exhaustive information on the full-scale specimen subjected to five shake-table test runs of progressively increased intensity.

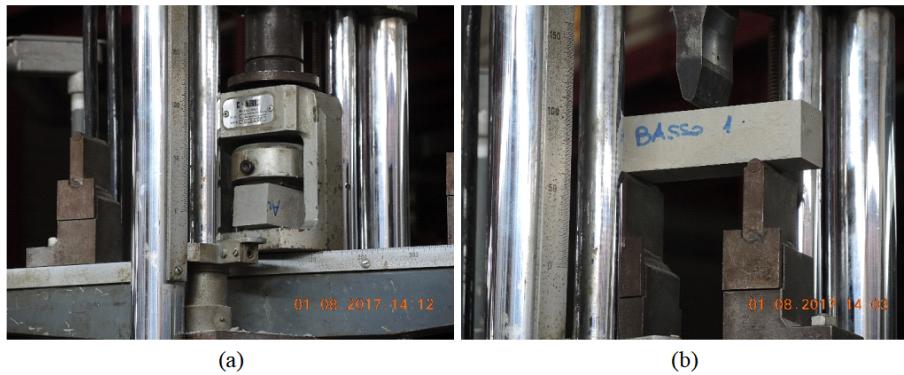
Figure 4: Photographs of the setup for (a) compression and (b) three-point flexural testing of mortar samples

Standard compression and three-point flexural testing of mortar samples was carried out, as shown in Figure 4, which presents the setup for each type or set of tests. Tests were undertaken according to EN 1015-11 [16], which sets standards for testing procedure and preparation of the prismatic samples to test. All mortar samples, whose dimensions are 160 x 40 x 40 mm, were cured following the recommendations of EN 1015-11 [16] and were tested in force-controlled mode, at a constant load rate. It is worth mentioning that three series of tests were performed to characterise the mortar (i) for the wall base joints, (ii) for the two- and three-way panel connections, and (iii) for the floor-to-wall joints, with the latter being made up of non-shrink, low-strength mortar such as that used for the other structural interfaces in this type of buildings (e.g. interfaces between two slab panels or between two adjacent transverse wall panels). Twenty-four mortar samples were prepared in total, meaning that three samples were prepared per each mortar supply.

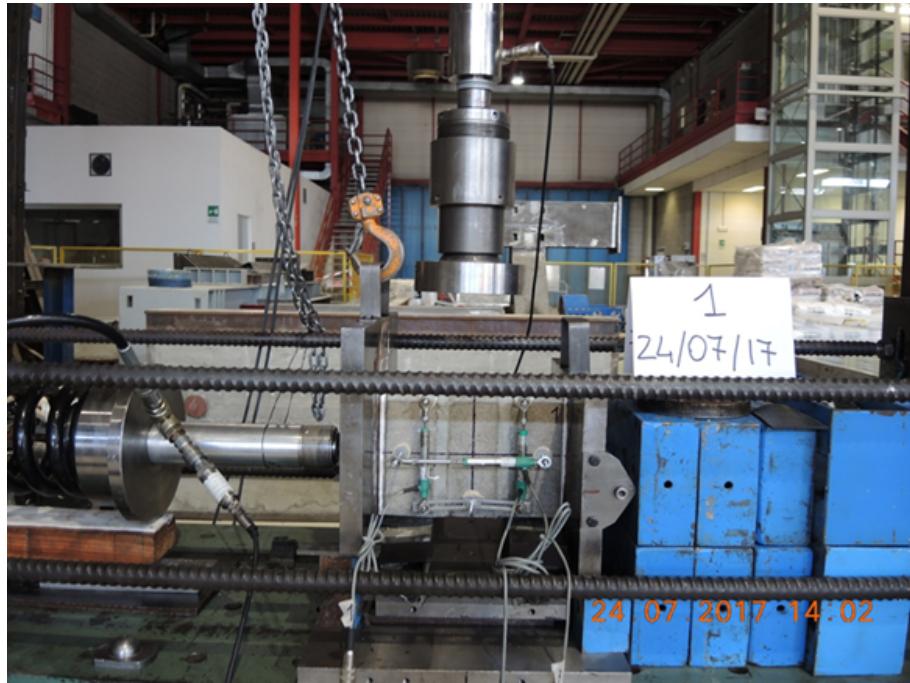
Figure 9: Example of concrete-mortar triplet specimen installed in the testing apparatus

In addition to previous characterisation tests aimed at assessing the bond strength of mortar, nine further triplet specimens, such as the one shown in Figure 9, were prepared and were each tested under three different levels of axial load so as to estimate the cohesion and frictional resistance of this material, something mandatory in reflection of the fact that, as discussed previously, in several existing buildings of this type the precast wall-elements are simply resting on their concrete foundations without any starter rebars that protrude from the foundation into the wall panel. This implies that the entire lateral-force resisting system of these precast wall-slab-wall structures relies only on the shear-friction resistance of mortar, as indeed confirmed by the shake-table tests undertaken by the same authors (Brunesi et al. [8]), whereby it has been showcased how damage in this type of buildings is inevitably associated with the base wall wet joints.

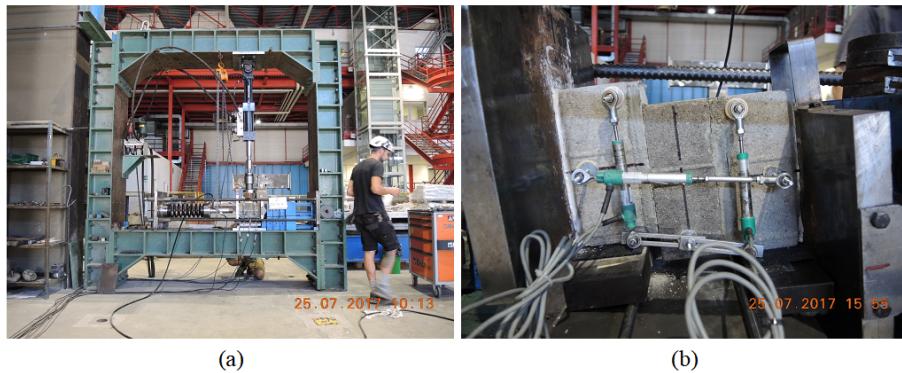
Figure 10: Friction testing of triplets: (a) test setup for application of vertical and horizontal forces and (b) triplet specimen at the end of the test

Figure 10 presents a photograph of the testing apparatus and an enlarged view of one of the triplet specimens, disassembled at the end of one sequence of tests.

The concrete blocks were 195 x 95 mm² and had thickness equal to 80 mm. The mortar layers were approximately 2 cm thick each, meaning that they were assumed to have the same thickness as that of high-strength mortar joints at the base of similar buildings in practice [8]. After each specimen was assembled, a uniformly distributed mass was applied on top of it in such a way that the triplet could be kept compressed and undisturbed until testing [21]. Triplet tests were all executed after 28 days of curing (EN 1052-3 [21]) through the following procedure.

The specimen, placed in the testing apparatus between two steel plates, is supported by roller bearings, and a compression force, chosen to be representative of the range of axial load values present in the walls of existing structures of this type (quantified below), is then applied to the two lateral faces of the triplet. To do so, the specimen is post-tensioned by means of four steel rods before the vertical force is applied to the central concrete block through an actuator in force control (Figure 10a). As shown in Figure 10b, each triplet specimen was instrumented using six displacement transducers such that the time instant corresponding to the activation of sliding could be identified, thus leading to the estimate of the shear force resisted by the mortar.

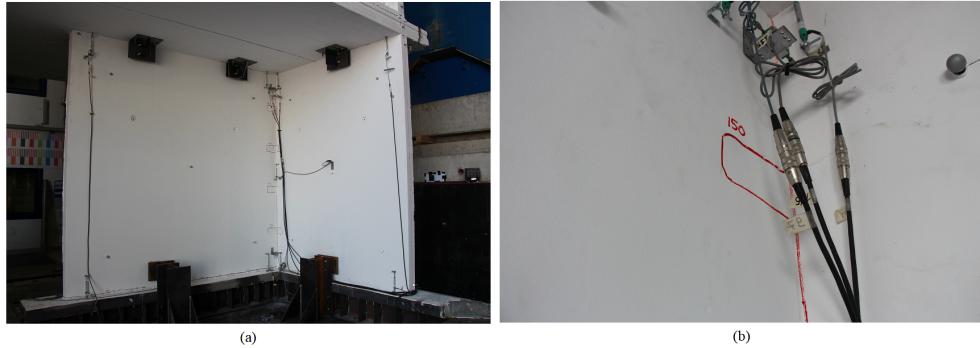
Figure 15: Damage mechanisms/patterns at the end of test run 150% (Brunesi et al. [8]): (a) full-depth cracks in the base wall joint and (b) example of cracks along the boundaries of the connectors' sockets

To corroborate further the above assumption, Figure 15 highlights the main damage patterns at the end of test run 150%, with the full-depth horizontal cracks in correspondence to the shear wall being the most notable occurrence (Figure 15a). Furthermore, Figure 15b shows

an example of the cracks developed all along the boundaries of the connectors' sockets, four in total. The resistance associated with this latter mechanism can be predicted as well, by computing the product of the mean bond strength of mortar, as obtained from bond wrench testing (Section 3.2), and the lateral surface of the four panel niches. Figure 13c compares the three capacity estimates and reaffirms their accuracy, with respect to the sequence and extent of damage mechanisms exhibited by the full-scale building specimen, thus adding further weight to the recommendations presented here and the testing campaign described in this paper.
