ASSESSMENT OF THE MOST DAMAGED HISTORIC CENTRES OF THE REGION EMILIA ROMAGNA DUE TO THE EARTHQUAKE OF THE 20th AND 29th OF MAY 2012

V.I. Novelli, Department of Architecture and Civil Engineering, University of Bath, Bath, BA2 7AY, UK, V.I.Novelli@bath.ac.uk

Key words: Emilia Romagna, historic centres, damage scenarios; assessment; seismic vulnerability

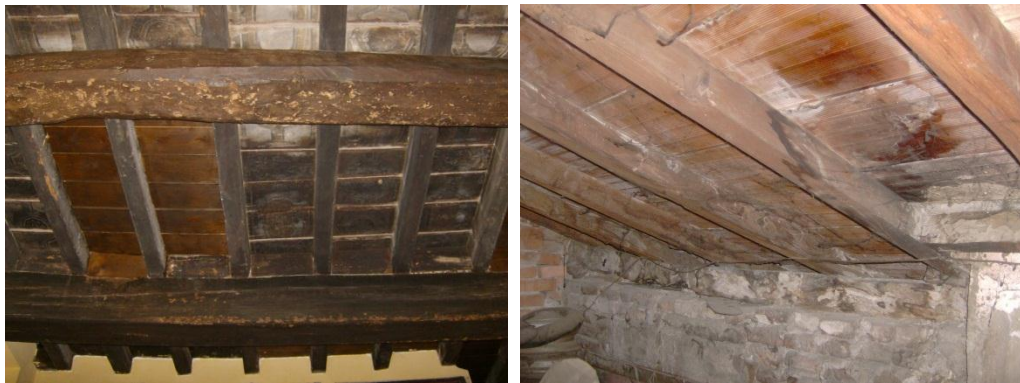
Figure 10: Timber floor and timber roofs inspected in a typical buildings in Emilia Romagna region.

The original horizontal structures include both masonry vaults and timber floors and roofs; see Figure 10, replaced in recently retrofitted buildings by reinforced concrete. Masonry vaults are usually present at the ground floor and they are often supported by porticoes, see Figure 11.

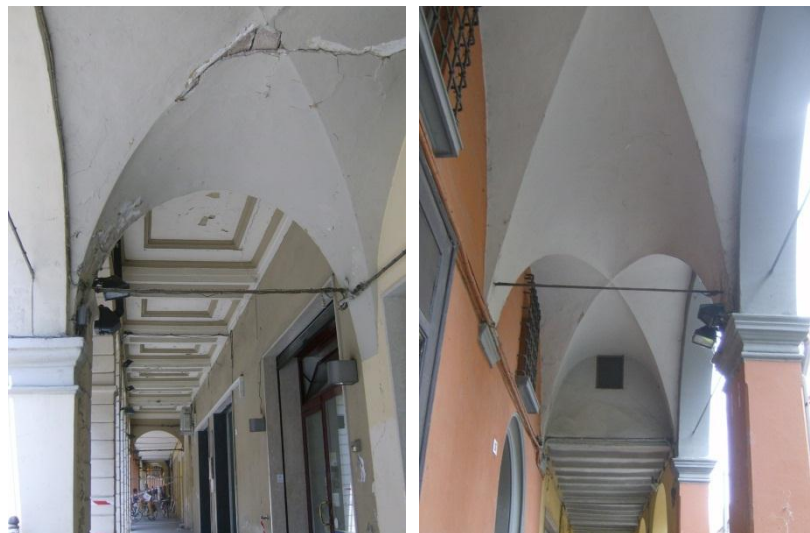
Figure 11: Masonry vaults supported by porticoes observed on the ground floor of the buildings.

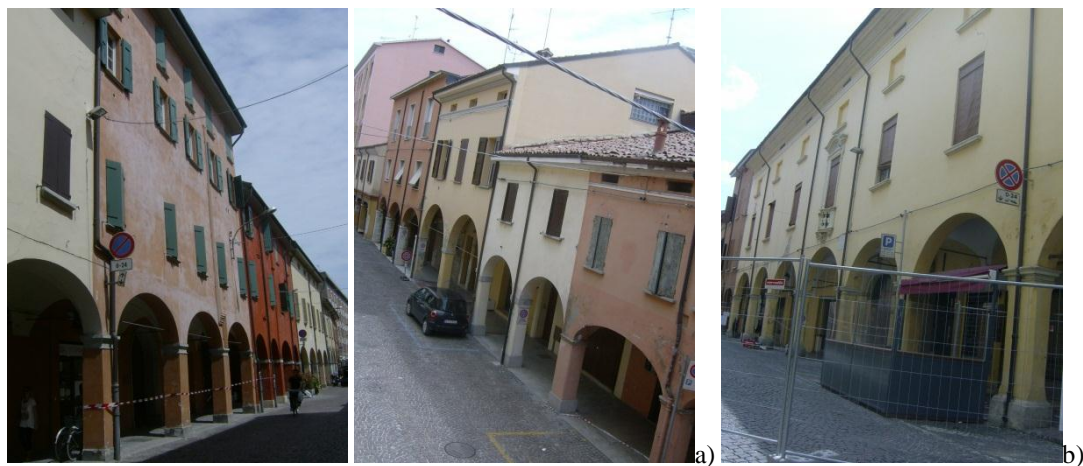
The presence of porticoes at the ground floor, see Figure 12, where shops and building's entrances are located, is the most representative feature of the constructions in this region. Indeed this element of discontinuity of the façades is also common to many other provinces and region of Northern Italy, as it had been already identified in a vulnerability study of Serravalle and Vittorio Veneto in the Veneto region (Bernardini et.al, 2008).

Figure 12: Porticoes in a) Malagodi street and in b) Provenzali street in the historic centre of Cento.

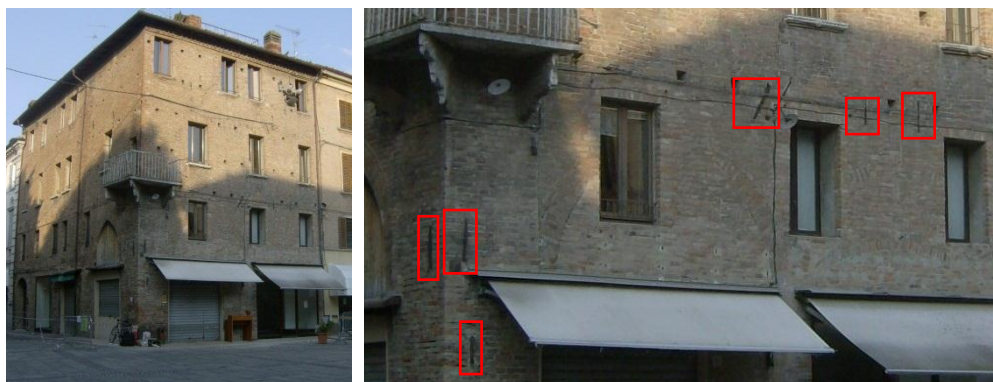
As many other historic centres in seismic prone areas, cross ties are a common feature, and they are inserted into the masonry, just below the floor level or above the openings, with metallic elements resting on the surface of the façades to improve the connections between orthogonal walls and between walls and horizontal structures, see Figure 13. As for the thrust generated by the vaults of the porticoes, this is also usually taken care of by the introduction of anchors, longitudinally and transversally which contribute to restrain the façades against out-of plane leaning or rocking, see Figure 14.

Figure 13: Metallic elements on the façades of the buildings on the corner between Costituente square and Volturmo street in Mirandola

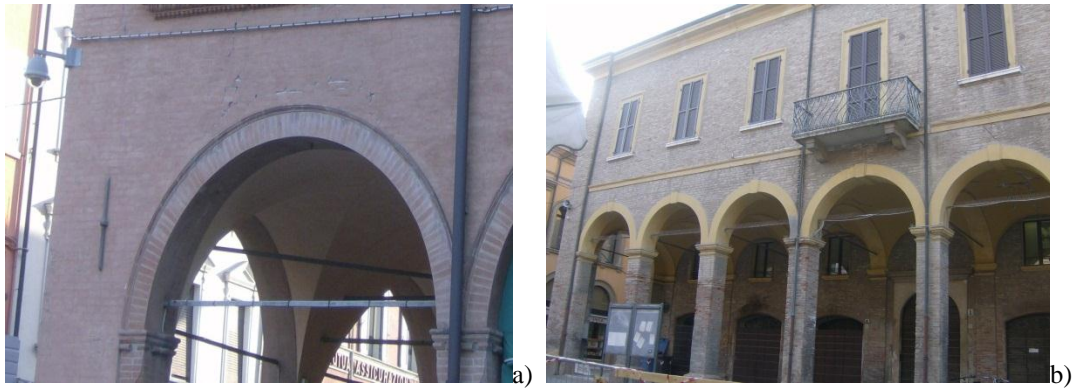
Figure 14: a) *Metallic elements and anchors in the arches of the façades of the building on the corner between Costituente Square and Felice Cavallotti street in Mirandola* b) *Anchors in the arches of the façade in Cesare Battisti street in Mirandola.*

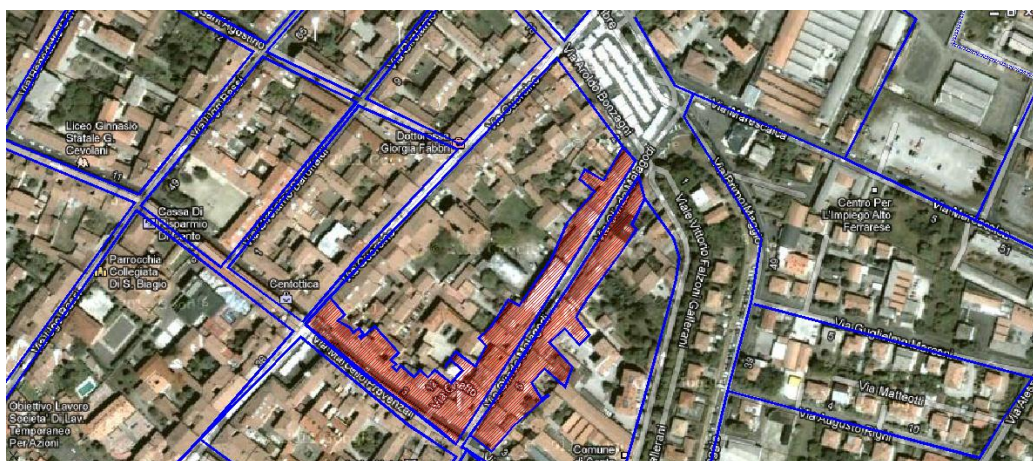
The surveys have been performed to collect the data required by the vulnerability model FaMIVE (D'Ayala & Speranza, 2003, D'Ayala 2005, D'Ayala & Paganoni, 2011) for the evaluation of the failure modes of approximately 30 buildings in the cluster mapped in Figure 21. The same buildings were also surveyed by the Italian Civil Protection for access clearing by using AeDES form (D.P.C.M. 23 February 2006 (G.U. 7.3.2006, n. 55 and O.P.C.M n. 3753, Gazzetta Ufficiale, 7th April 2009, n. 81, (2) in Italian).

Figure 21: *Historic centre of Cento and mapping of the inspected buildings.*

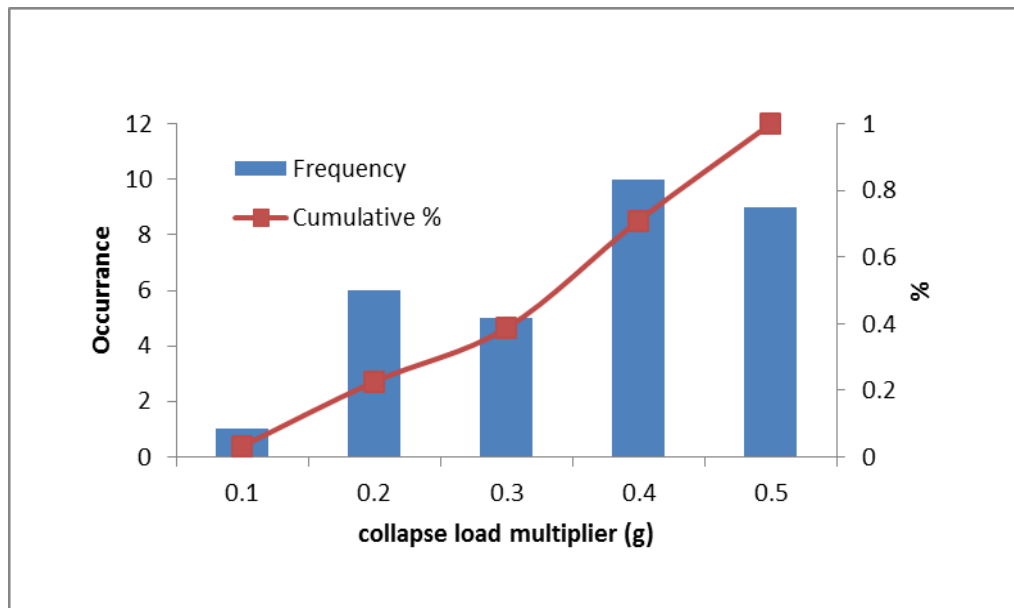
The distribution of collapse load factors (λ), calculated for the selected buildings is shown in Figure 22 with a median value of 0.32g and standard deviation of 0.11g. This result is obtained assuming that connections of the façades with the side walls are good, as per the observation on site. The median value of maximum lateral capacity of the sample can be compared with the a_{refg} (10% probability of exceedance in 50 years) for the Comune di Cento provided by <http://www.isesd.cv.ic.ac.uk/ESD/> for the seismic assessment of structure in third level analyses. The peak ground acceleration for the Comune of Cento, classified in zone III in the OPCM n. 3274 / 2003, is 0.157g, with a maximum elastic spectral amplification of 2.7 for a period of $T=0.2$ sec.; such values justify the good response of the buildings observed on site. Such performance is also confirmed by the results of the survey for the occupant safety carried out by the Italian Civil Protection using the AeDES form, according to which only few buildings fall in the category of partially or totally unfit for use.

Figure 22: Collapse load factors multiplier (g) distribution calculated on the selected historic buildings of Cento.

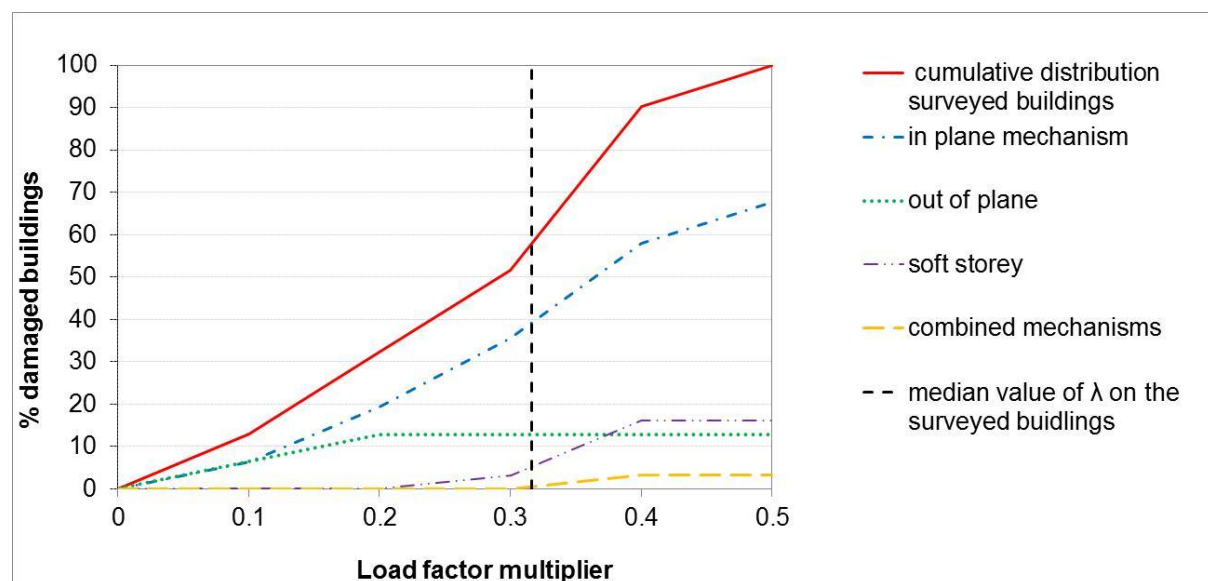
Figure 23 shows that in-plane failure is the most common for the inspected buildings, with 67% of façades failing for in plane mechanism, 16% for soft storey, 13% for out of plane and 3% for combined mechanism, in which both the façade and the side wall participate in the overturning.

Figure 23: Load factor multiplier (λ) distribution in the surveyed sample in the historic centre of Cento.

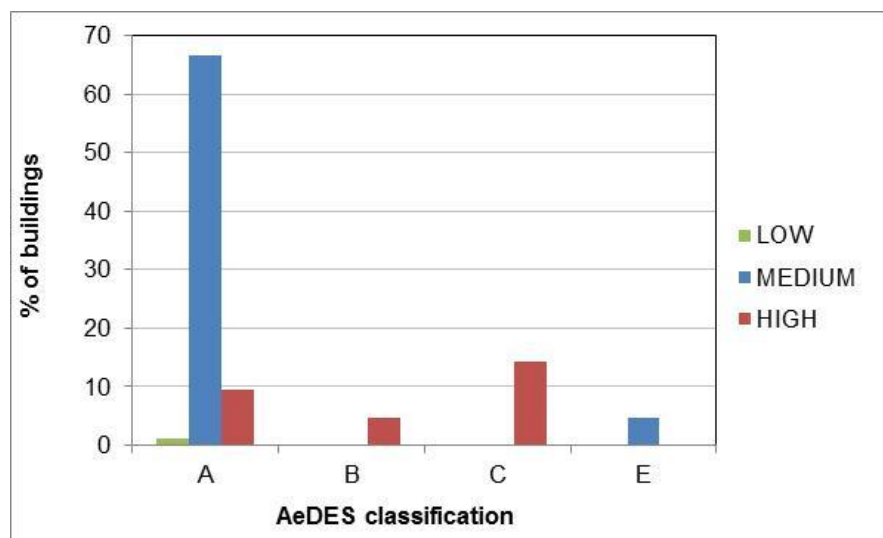
Moreover it has been observed that the few inspected buildings classified as unsafe by AeDES, class E, are not particularly vulnerable for FaMIVE. This incongruence is justified since those buildings considered unsafe by AeDES were already unfit for use before the earthquake.

Figure 24: Comparison between the damage scenario classified by AeDES and the vulnerability level obtained by FaMIVE of the historic centre of Cento.

Figure 24 shows that the classification provided by Civil Protection results in only 4% of the inspected buildings in class E: unfit for use, and 13% in class C: partially unfit for use, while 13% is classified as B: temporary not safe or safe if repairing interventions are carried out and 70% as A: safe.

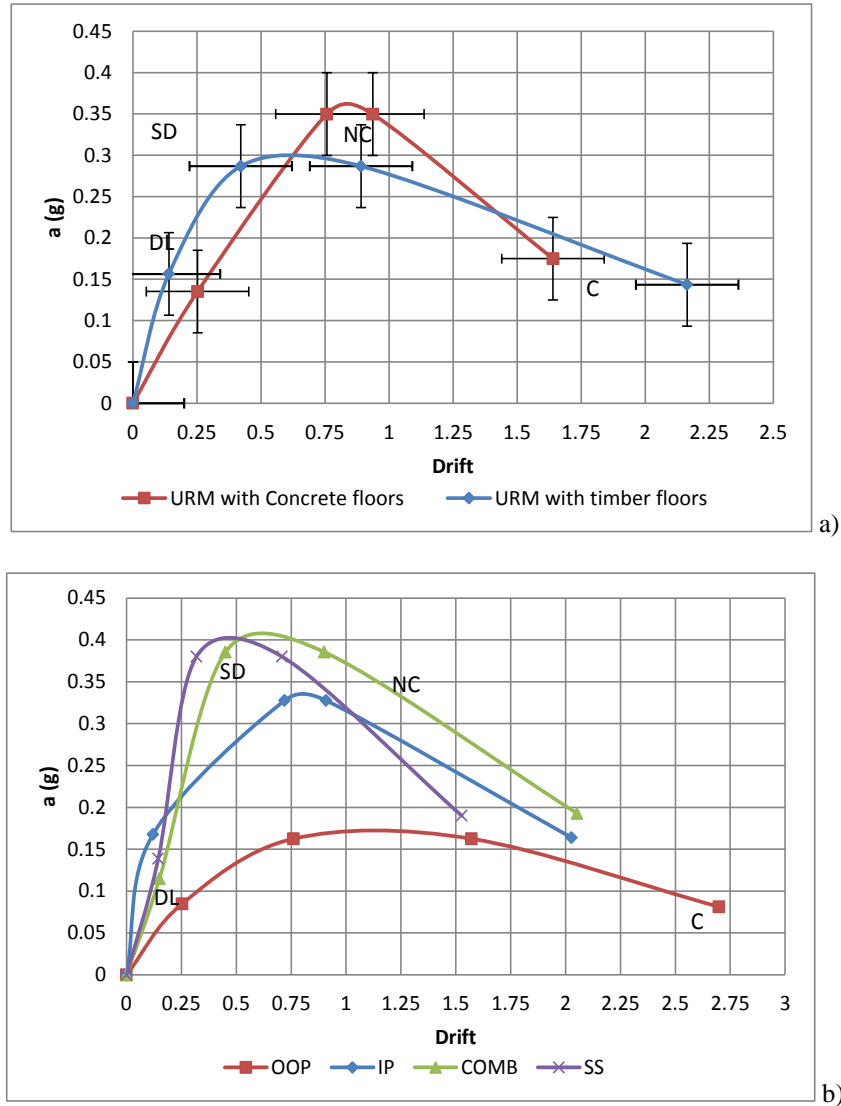
The capacity curves are shown in Figure 25 for the two major groups of construction typologies identified: unreinforced fired brick masonry with timber floors and roof, and unreinforced fired brick masonry with concrete floor slabs and roof. Figure 25a shows that on average the buildings with concrete slab floors have greater lateral capacity but reduced ultimate ductility and most importantly a relatively brittle behaviour, when compared with the less strong but more ductile timber floor structures. Figure 25b shows the average

capacity curve with the indication of the limit state representative points for class of failure mechanism, out-of-plane (OOP), in-plane (IP), combined (COM) and soft-storey (SS). The out of plane mechanism are in this case, as stated before, local mechanisms of upper spandrel overturning, concentrated at the top floor level, and usually triggered by low level of lateral acceleration. However as they involve a modest portion of the façade they are considered in the class of low vulnerability. The soft-storey curve has a capacity higher than the in-plane one, but brittle, while the combined mechanism has higher capacity and similar ductility to the in-plane mechanism.

Figure 25: a) Capacity curves for buildings with unreinforced fired brick masonry with timber floors and roof and b) Capacity curves for buildings with unreinforced fired brick masonry with concrete floor slabs and roof.

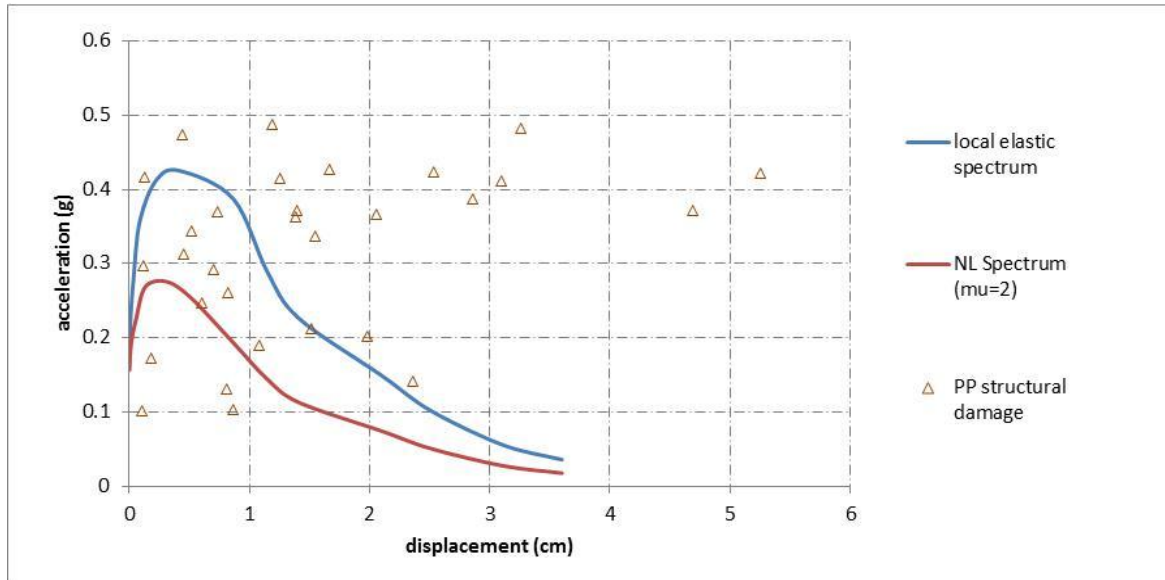
Finally in Figure 26 the performance points for the limit state of structural damage, associated to the life safety condition in EC8 is compared with the 475 years return period acceleration displacement elastic response spectrum, with the peak ground acceleration a_{ref} (10% occurrence of exceedence in 50 year), provided by <http://www.isesd.cv.ic.ac.uk/ESD/>. The nonlinear spectrum for a ductility value of 2 is also provided for reference. This is calculated using the N2 method approach (Fajfar et al. 2000), recommended by Eurocode 8 part 3 for assessment of seismic performance of existing buildings. It can be seen that most

representative points are located above and on the right hand side of both curves and only a minority is below the red curve, indicating that the performance of these buildings will be worse than just structural damage. It should also be noted that the a_{ref} for 475 years is greater than the value indicated for Cento on the shaking map of Figure 3 and Figure 4. This analysis confirms the relatively low level of damage and good performance identified by the on-site survey and the FaMIVE analysis.

Figure 26: Comparison between the performance points for the limit state of structural damage, , associated to the life safety condition in EC8 and the 475 years return period acceleration displacement elastic response spectrum, with the peak ground acceleration a_{ref} (10% occurrence of exceedence in 50 year), provided by <http://www.isesd.cv.ic.ac.uk/ESD/>.
