# The Emilia-Romagna earthquake: Damages to precast/prestressed reinforced concrete factories

A. Marzo\*, G. Marghella\*\*, M. Indirli\*\*\*

**Keywords:** precast structures, factories constructions, seismic damages, Emilia Romagna earthquake.

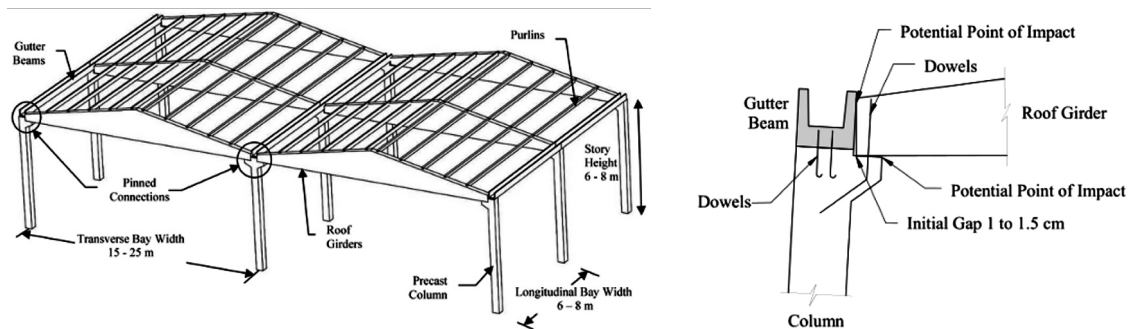
Fig. 2. A Turkish typical configuration of one storey precast construction near Kocaeli and details (Senel and Kayhan, 2010).  
Tipica configurazione Turca di costruzione prefabbricata ad un piano presso Kocaeli e dettagli (Senel e Kayhan, 2010).

Some typical one-storey industrial pre-cast structures [Fig. 2, see Senel and Kayhan, 2010], located in the

epicentral area of the August 17<sup>th</sup>, 1999 Kocaeli earthquake [Turkey,  $M_w$  7.4, see EERI, 2000], didn't show good results, while others remained undamaged [Fig. 3, Saatcioglu et al., 2001]. The collapse was mainly due to poor design, detailing, and construction, leading to the lack of diaphragm action caused by the inadequate connections (pinned or dowel, simple to realize by the prefabricators) between columns and beams. In addition, buildings under construction were susceptible to collapse when the roof girders rotated off their supports [Posada and Wood, 2002; Doneux et al., 2006].

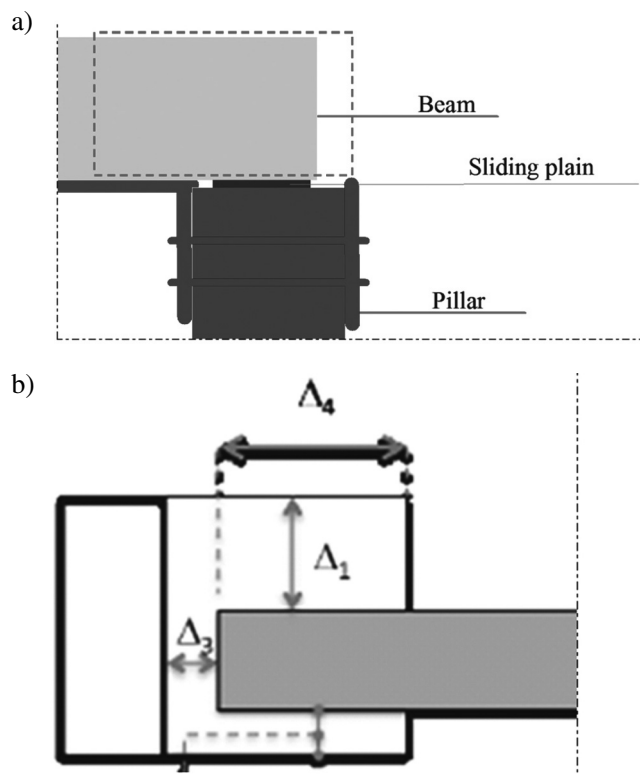
Fig. 19. Sliding constraint; a) a practicable solution; b) sliding surface.  
Vincolo a scivolamento; a) una soluzione praticabile; b) superficie di scivolamento.

steel bars is absent. According to the dimension of the support, specific interventions should be realized in case of absent or inadequate shear resistant systems, aiming at the reduction of both beam-covering and beam-column relative displacements (see Fig. 6a). At this purpose, the realization of steel connection systems can be useful to upgrade or retrofit the support perform in case of both sliding and fix constraints, thanks to their easy and speed in execution. Sliding connections should be designed taken into account the main seismic displacement (Fig. 19). On the other case, the fix constraints should not lead additional significant moments to the connected parts (beam and column) because they are not designed to perform this stress. Therefore, a hinge constraint was also suggested at the column-beam connection (Fig. 20a,c). The consolidation of the column forks can be realized by means of steel elements, similarly, where it is required (Fig. 20b). The decrease of the permanent load can be useful in case of upgrading of the shear connection strength. Covering structures can be suspended to an *ad hoc* system. In addition, the reduction of relative displacements in x direction (column-beam, see again Fig. 6a) should be also realized. In any case, it is necessary to carry out shear connection elements. Finally, vertical connection between structural elements should be realized by considering the results of in situ inspections, if the vertical seismic component can produce relevant effects.

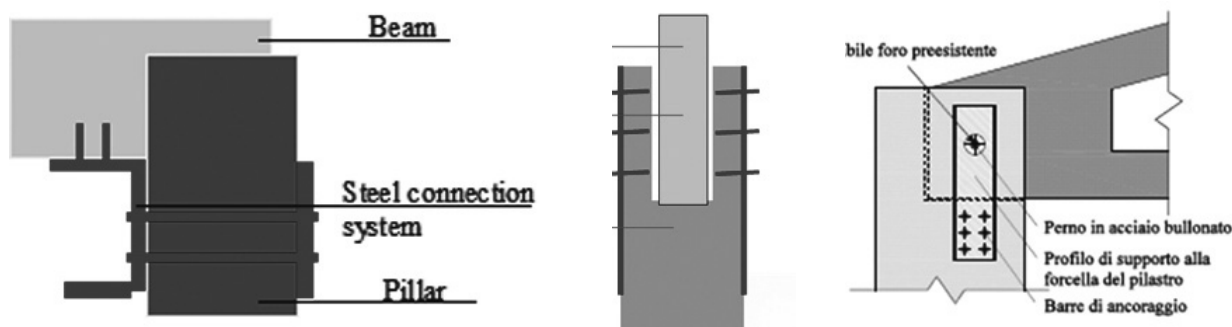
Fig. 20. Fix constraint; a) a practicable solution; b) forks consolidation system; c) solution suggested by DPC 2012.  
Giunto fisso; a) una soluzione praticabile; b) rinforzo della forcella; c) soluzione suggerita da DPC 2012.
